# Saab 9-3 - Loss of coolant | HELLA

**9-3**

**Engine code: B284.**

## **Loss of coolant**

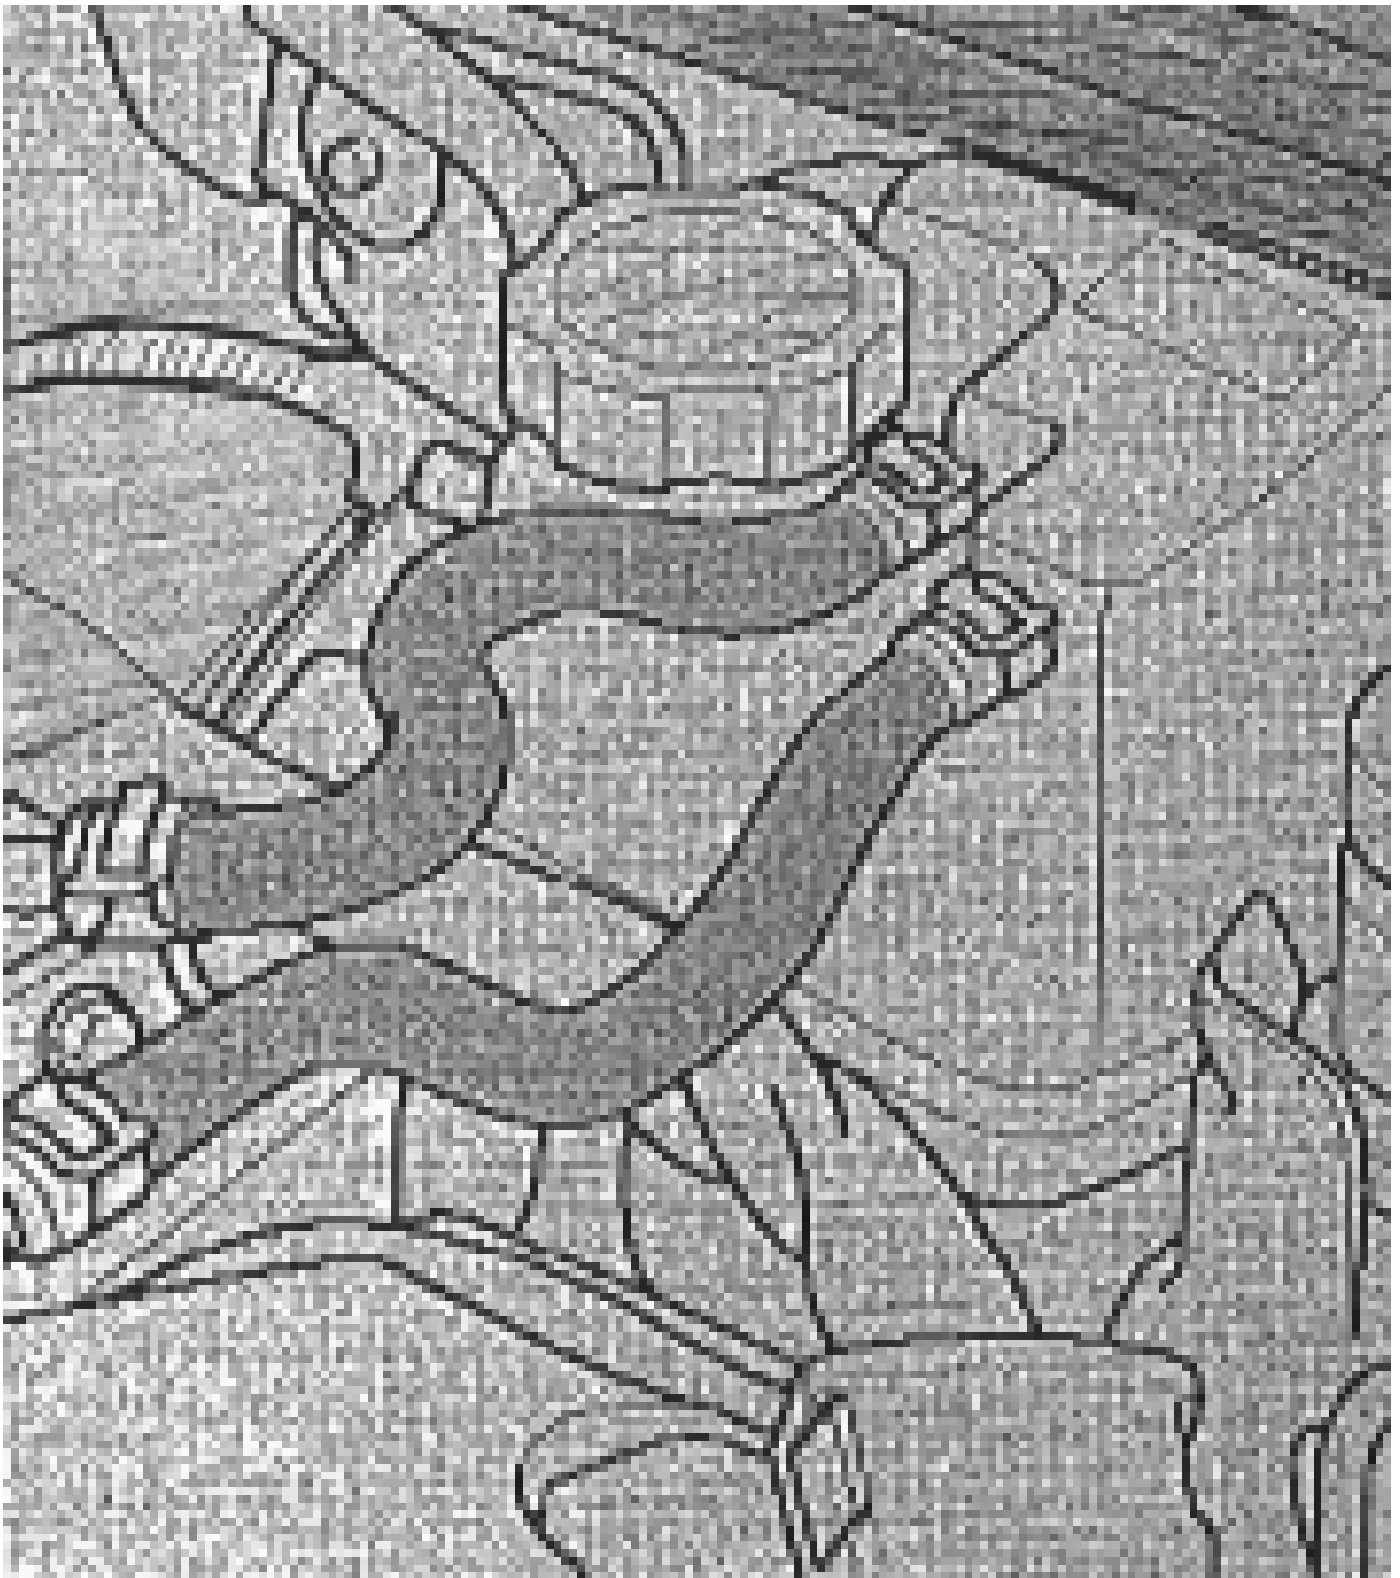
Figure 1

In the case of the above-mentioned vehicles, problems can arise because of loss of coolant. The cause of this can either be a defective coolant expansion tank or damaged engine coolant hoses on the coolant expansion tank.

The positioning of these components (Figure 1) is located very close to the turbo charger, which means that material fatigue can result because of the hot ambient temperature.

(Old layout)

In order to remedy this, the coolant expansion tank is to be replaced and the hoses of the coolant expansion tank are also to be replaced / repositioned.

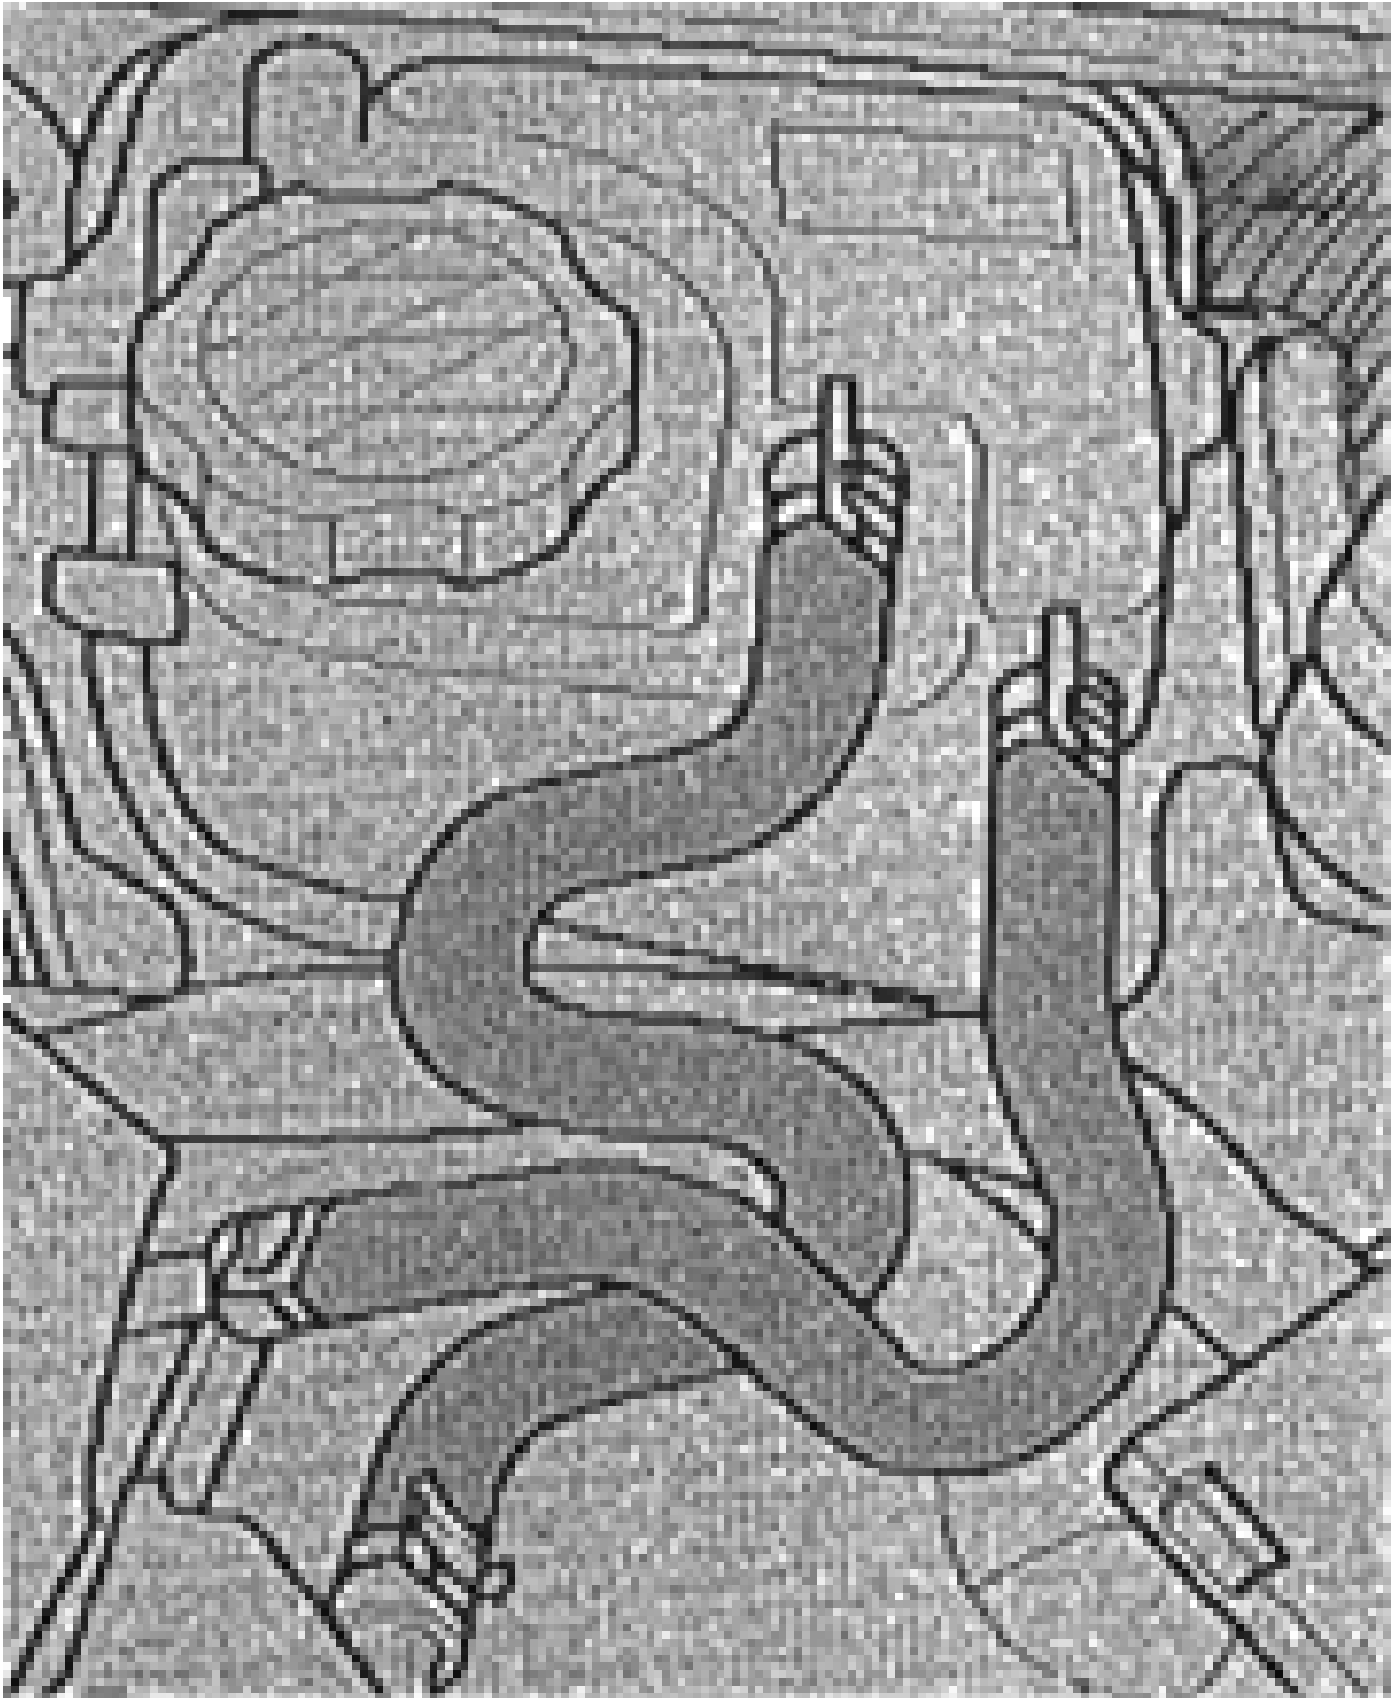
Figure 2

(Modified layout)

The car manufacturer provides modified coolant hoses for this specific purpose (See Figure 2).

Spare part no: 93 194 927

- 1\*set engine coolant hoses

Spare part no:12 759 330

- 1\*Coolant expansion tank.
