# Saab 900 II - Speed control for heating-system fan | HELLA

**900 II**

**Year of manufacture: 1993 - 1998**

## **Speed control for heating-system fan**

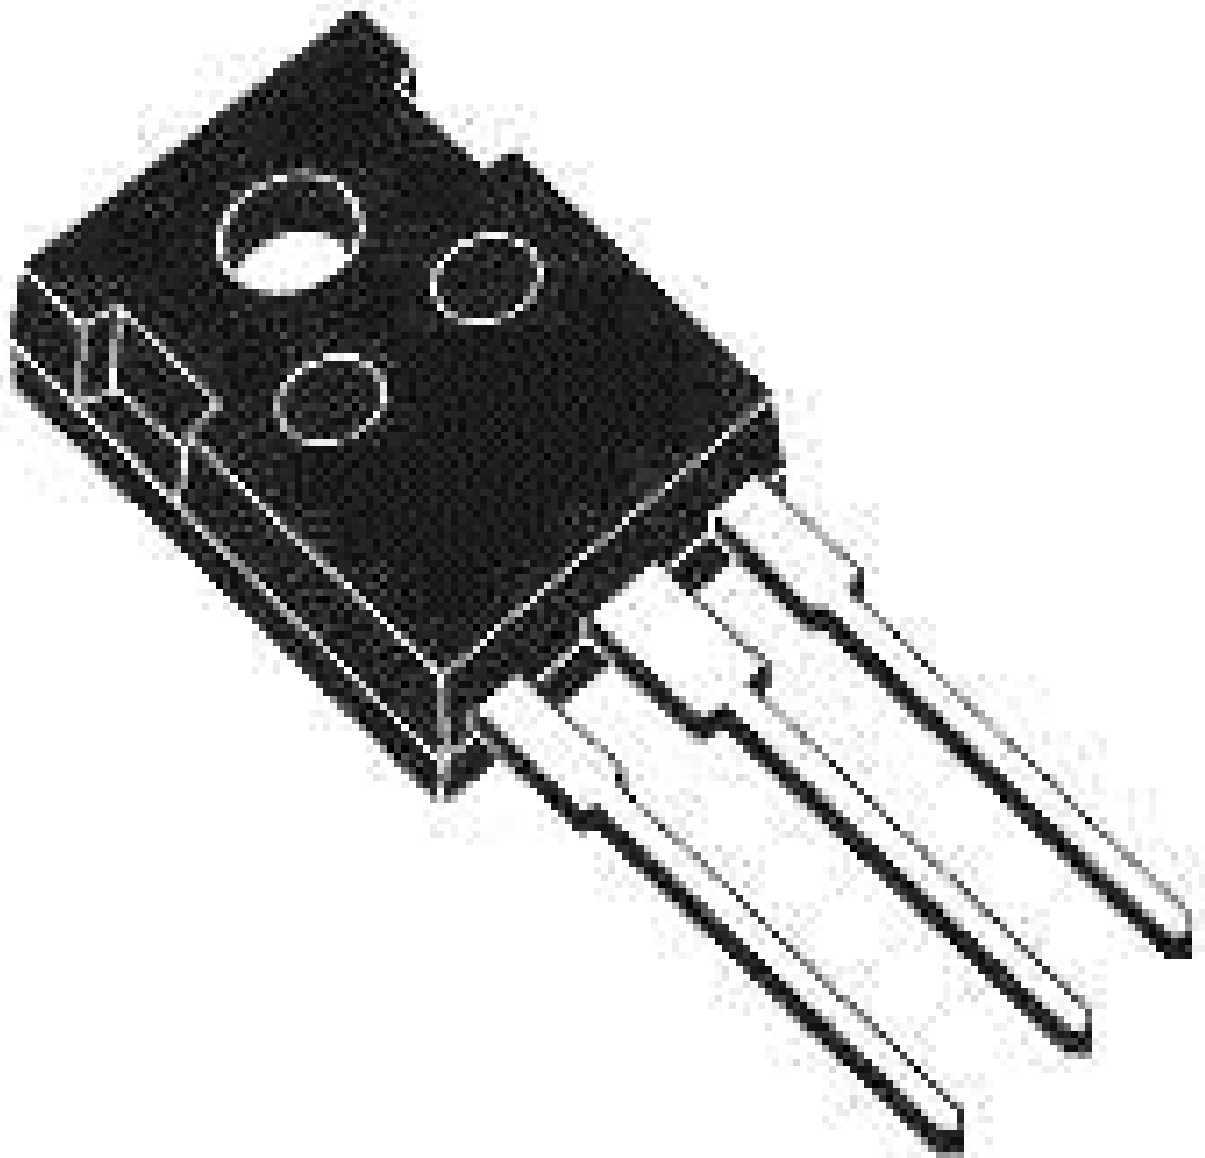
If the fan speed can no longer be controlled by the control unit or the fan operates only at the highest setting, the cause is probably a defect in the electronic fan control unit. In most cases, the transistor (MOSFET) on the circuit board has failed.

Somewhat skilled technicians could also repair the control unit by replacing the transistor.

- Transistor (Type IRFP064N), see drawing
- Soldering iron, ca. 30W
- Desoldering pump
- Solder
- Thermal grease
- Screwdriver, narrow
- Blade
- Harness tape, temperature-resistant
