VW Golf V - Poor engine starting performance | HELLA

Golf V

1.9D TDI PD

Engine code: BKC

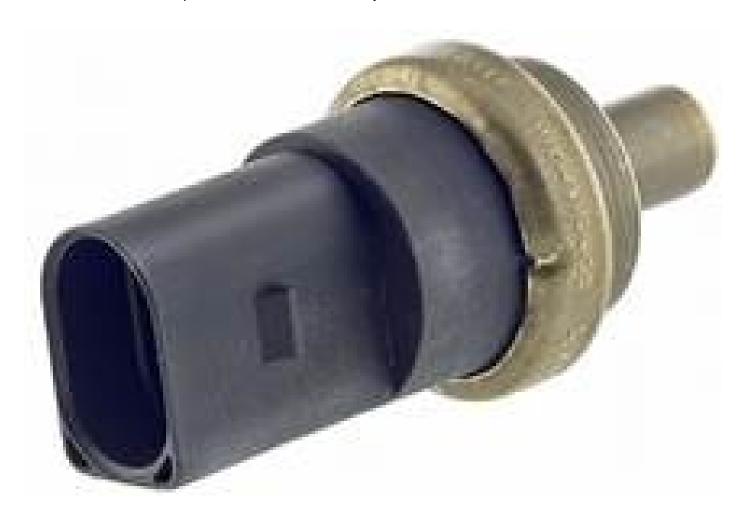
Figure 1.

If the fault pattern listed above is reported, the cause may be a defective coolant temperature sensor. In addition, error codes (triggered by implausible sensor values) may be stored in the engine control unit.

Replace the sensor if necessary (see Figure 1.).

Hella coolant temperature sensor: 6PT009309-331
