VW T6 - replacing the differential pressure sensor

Data sheet	
Manufacturer	Volkswagen
Vehicle model	Transporter T6
Engine	2.0-litre Diesel
Engine code	CXHA
Year of manufacture	2015 - 2019
Symptoms	Replacement of differential pressure sensor

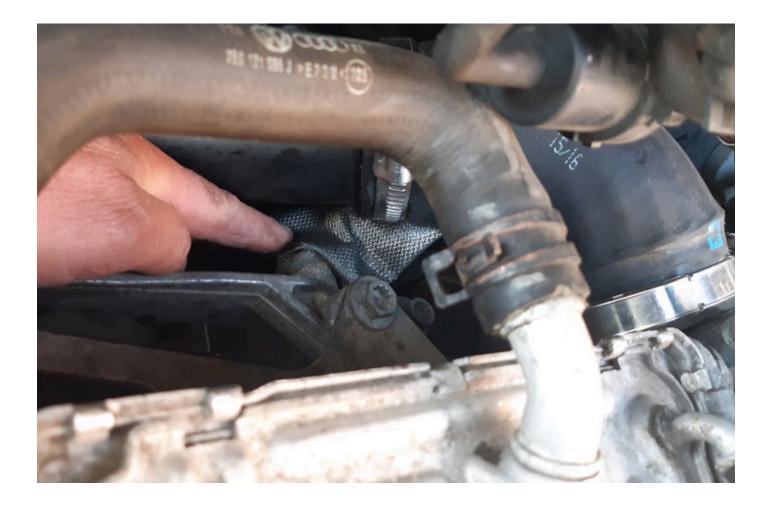
The sensor, wrapped in heat protection foil, is located behind the hose of the charge air cooler, as shown in (Fig. 1
). In order to access the sensor, the charge air hose or the charge air pipe has to be removed as seen in (Fig. 2
). This is done by removing 2 screws in the lower section. Loosen the hose clip at the top of the charge air cooler(Fig. 3
). Now it will be possible to remove the hose/pipe combination (Fig. 4
). After opening/removing the heat protection foil, the sensor becomes visible. It can now be replaced with a sensor, for example, from HELLA (Part no: 6PP 009 403-221).
