# BULLETIN

## Volkswagen Model: Golf V Plus Engine code: BLF Model year: 2005 – 2009

### ABS/ESP warning light illuminates

Error code: 1435

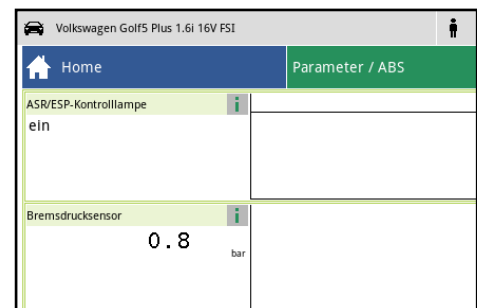
If the above error is discovered together with an illuminated ABS warning light, this may be due to the brake fluid pressure sensor.

The pressure sensor records the brake pressure in the hydraulic system and relays the value to the control unit. A signal evaluation error results in an error being entered in the control unit. As it is not possible to take measurements on the sensor itself, first of all check the parameters in this case. The setpoint should be 0 bar when the brake is not applied. The sensor must be replaced in the event of deviating values (figure).

The pressure sensor is integrated in the ABS hydraulic unit. The vehicle manufacturer offers a repair kit for the ABS hydraulic unit.
