Audi A6, all models model years 1997 – 2004

Engine doesn't start

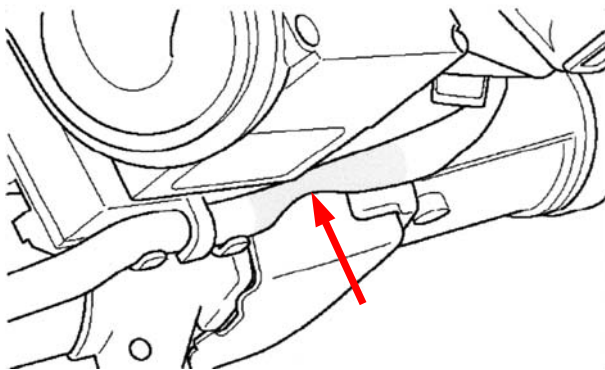
If this fault is complained about, then a damaged wire harness of the immobilizer may be the cause. Also the error "Signal from receiver coil or key too weak" may be stored. The wire harness may have been installed in such a way that the steering column casing damages individual cables of the wire harness.

- Dismantle steering column casing.
- Check wire harness for damage (see Fig.), broken cables etc. and repair if need be.
- After repair, install the wire harness in such a way that damage is ruled out.
