BMW 5-series (E39) All models before 1 Nov. 2002

Insufficient power

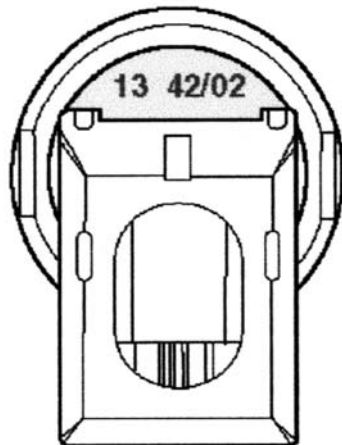
If this fault is complained about, then the cause may be defective ignition coils. Various error codes are stored and the engine control lamp lights. Backfiring may also be complained about. In that case, the ignition coils must be checked. If Bremi type ignition coils are installed, then the production date must be checked which is attached at the coil end. The last four digits indicate the production date (see Fig.). If the coils have been manufactured prior to the 42nd calendar week of 2002, then they should be replaced.
