## *BMW E 39 up to 12/95 Flickering headlight*

In headlight levelling position 2, light /dark border changes permanently

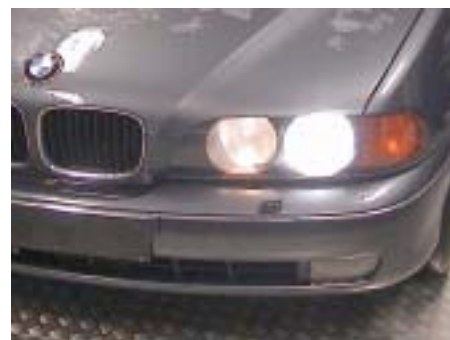
With a loaded vehicle and the headlight leveling switch in position 2 (max) it is possible that the servomotors are constantly moving. This is caused by an incorrectly fixed potentiometer on the circuit board of the levelling control unit, this in turn causes a voltage change leading to the servomotors repositioning.

In this case the headlight levelling switch must be replaced. From beginning of December 95, this fault has been eliminated through an improved headlight levelling switch and control.
