Fiat Stilo with petrol engine

Noise from valve of activated carbon canister

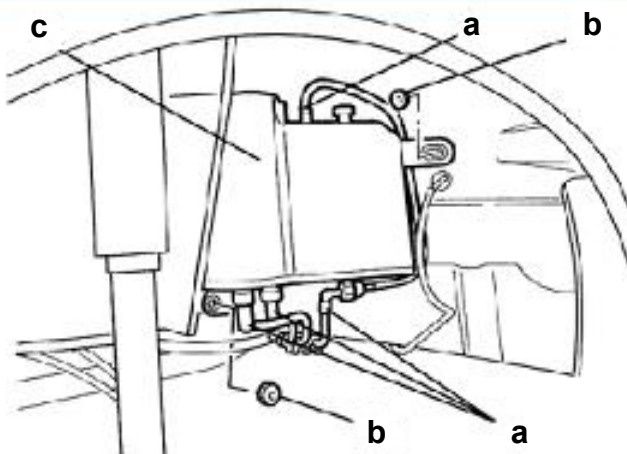
With the above-mentioned vehicles, noise can sometimes be heard coming from the rear right-hand side of the vehicle when on bumpy roads. The noise is usually caused by a metal ball inside the multi-function valve of the activated carbon canister. The only way to solve the problem is to replace the complete activated carbon canister including the integrated multi-function valve. If a replacement has already taken place, there will be a white spot of paint on the head of the lower attachment screw of the fuel tank flap.

The activated carbon canister (see illustration, item c) is at the rear right-hand side of the wheel housing. For dismantling, the hoses (see illustration, items marked "a") and the attachment nuts (see illustration, items marked "b") have to be removed.
