Ford Explorer, model year 1993-1994

Rough engine running

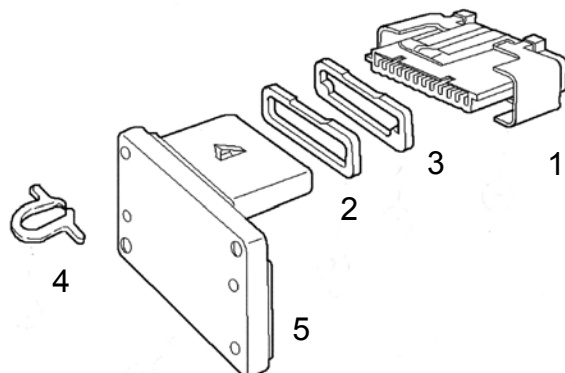
If there are complaints about the above-mentioned fault, the cause may be a loose connector on the ignition control unit. Due to this connector, moisture can penetrate the inside of the connector. A repair kit is available for this. The repair kit contains a new connector clip, as well as a special seal made of silicone. The new connector clip prevents the connector from becoming loose, and the seal offers better protection from moisture penetration.

- Switch off the ignition.
- Remove the connector (1) from the ignition control unit
- Remove the old foam seal (2, bright orange) from the connector.
- Insert the new (3) seal into the connector. Ensure that the seal is seated securely.
- Fit the new connector clip (4) to the retaining lug on the ignition control unit (5).
- Connect the connector to the ignition control unit.
