## **Ford Ka, Fiesta Model year '96 Ford Puma up to 09.99, design code XJ**

### **Blower motor does not function in the switch positions 1, 2 or 3. Noticeable development of smell and smoke.**

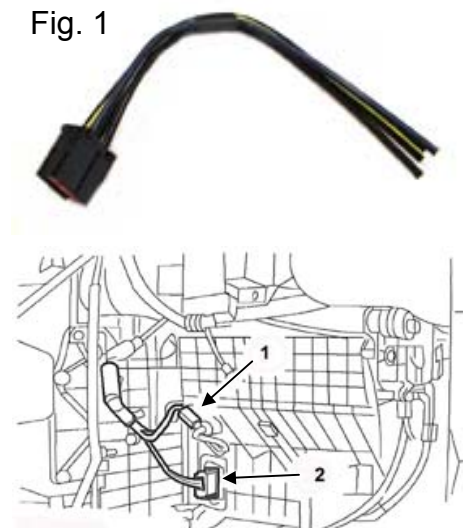
Fig. 1

If there are complaints about the above-mentioned points, the resistor in the blower motor could be the cause of the problem. The high current consumption of the blower motor resistor can make the blower switch plug melt. In this case, a new plug and a modified resistor have to be installed.

1. Blower motor plug
2. Resistor plug - blower motor

- Shorten the cable (faulty plug) by approx. 40 mm and insulate the ends of the cable by about 5 mm
- Adapt the length of the repair cable (see fig. 1) accordingly, and insulate the ends by about 5 mm. Push on pinch/solder connections (Hella no.: 8 KW 744 890-003)
- Now bring together the repair cable with the other cable and crimp the crimp connections using a crimping tool
- Then warm the solder connections so long with a hot air gun until the sealing agent escapes at the ends
- Insert the repair plug on the resistor and lay the cable again
- Reassemble the rest of the components in the reverse order to disassembly
