Ford Mondeo '97 **Build range from 08/96 – 11/99**

Intermittent failure of the loud speaker .

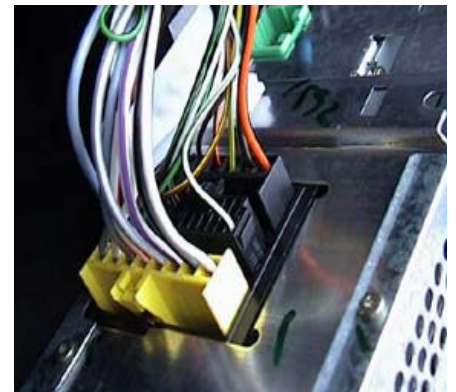
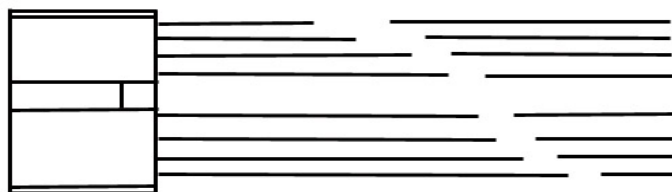
If the complaint on this vehicle is a intermittent failure of the loud speaker system, it could be due to a faulty connector on the radio. Due to warming the resistance in the connector becomes high. To rectify the problem the loud speaker connector must be renewed. For the renewing consider the following steps:

- Ensure that the radio code is available.
- Remove the radio, disconnect the connector for the power supply and loud speaker.
- Cut off the loud speaker connector diagonally (use the cable of the new connector as a measure, see picture below).
- Cut off the cable isolation, slide the shrinkage sleeves over the cable and solder the new connector (do not use squash connectors).
- Slide the shrinkage sleeves over the soldering point and shrink using a heat gun.
- To prevent any noises, tie the repaired cable with isolation tape.
- Connect the power supply and loud speaker connector to the radio. Fix the loud speaker cable with a cable tie to the radio.
- Refit the radio, enter the code.
- Check the function
