Ford Transit with double rear door, model year 2000

Failure of the heated rear window and/or central locking system.

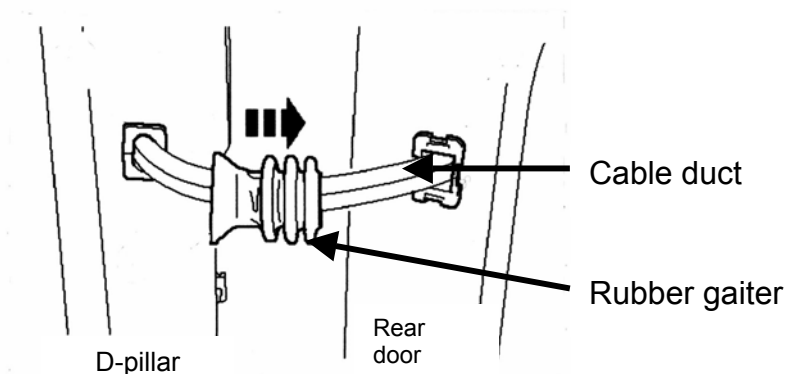
If there are complaints with this vehicle that the heated rear window and/or the central locking system fail, one possible cause is damage to the wiring harness on the rear door.

To eliminate the problem, a modified wiring harness with a reinforced cable duct must be installed. To do this proceed as follows:

- Remove the panelling on the rear door and remove the sealing foil in the upper area.
- According to equipment level, separate the plugs for heated rear window, the central locking system and the third brake light.
- Remove the rear lamp. The plug connections which must be separated for the rear door wiring harness are behind the rear lamp.
- Remove the rubber gaiter (see illustration) and unclip the cable duct from the door and the D-pillar.
- Pull out the wiring harness.
- Fit the new wiring harness and refit all the components in the reverse order of removal.
- Check all systems to make sure that they are working.
