Ford Windstar Model 1995 - 1998

Failure of the central locking, moisture in the cargo area

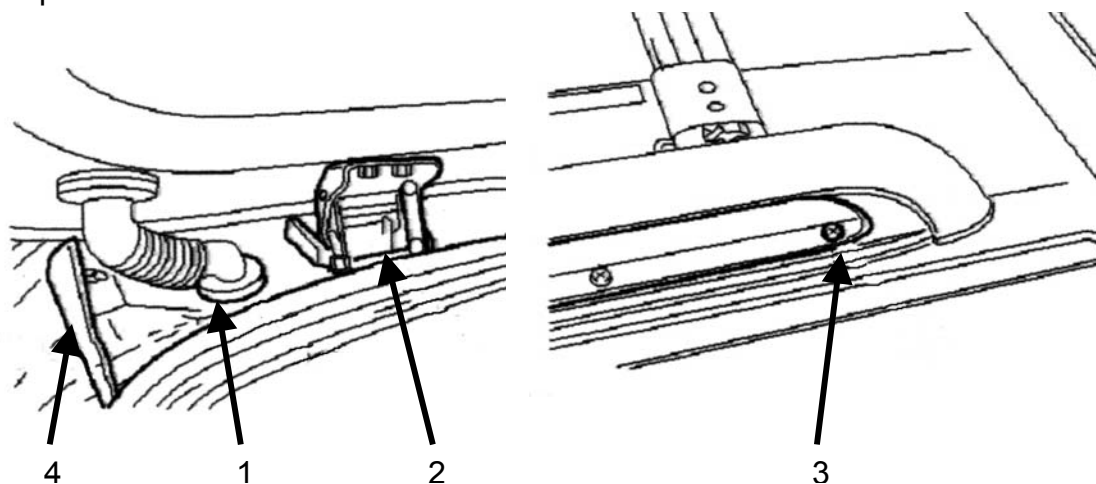
If there are complaints in relation to these vehicles concerning central locking failure and moisture in the cargo area, possible causes are leaks in area of the roof rails and the cable ducting to the tailgate. Water which has penetrated collects in the central locking switch for the tailgate, leading to faulty operation/failure of the central locking. To localise the leak, the left-hand rear side trim panel must be removed, and the left-hand side rear roof area of the vehicle must be sprayed with water. Water could possibly enter in the following places (see illustration): 1. the rubber grommet for the wiring harness to the tailgate, 2. the left-hand hinge of the tailgate, 3. the rear screw for the left-hand roof rail, 4. the seal between the roof frame and the D-pillar.

Once the leak has been localised it must be sealed using a suitable sealing agent.

The central locking plug and switch in the tailgate must be dried and checked for corrosion, and, if necessary, cleaned or replaced.
