## ***Land Rover Defender 90/110/130 model years 1999 – 2004 with engine 2.5L TD5***

### **Insufficient power**

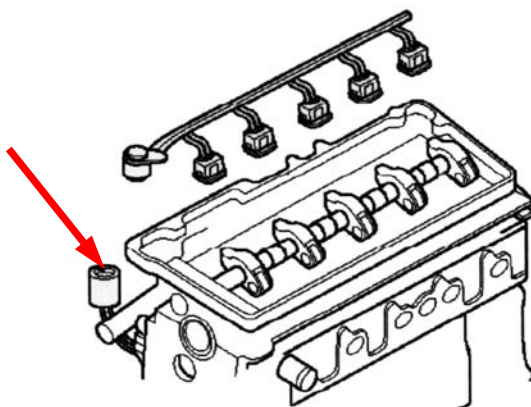
If this fault is complained about, then an insufficient sealing of the plug (see Fig.) between the engine wire harness and the wire harness for the injection valves may be the reason.

Backfire, engine start failure and lighting of the engine control lamp may also be effects of the fault.

- Detach the plug and check it for soiling.
- If the contacts are soiled by oil etc. then clean them with a suitable cleaner until correct contacting is guaranteed.
- If the contacts are heavily corroded by water, then the wire harness for the injection valves and the engine wire harness need to be replaced.
- Ensure correct fit of the plugs.
