Mercedes W201

Model year: 1990–1993

Engine: 1.8 i (M102.910)

Fluctuations in idling / sometimes no pulse duty factor

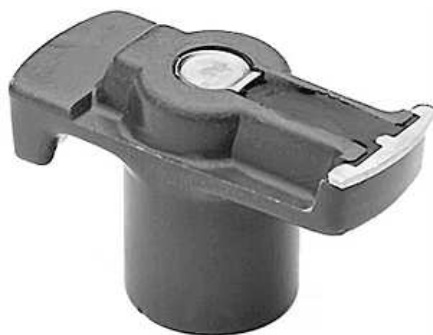
There can be significant fluctuations in idling speed with the above-mentioned vehicles. Sometimes there is no signal applied to Pin 3 of the diagnostic connection, so that no pulse duty factor is indicated.

Distributor rotors and caps are often replaced within the course of servicing or maintenance work. Check whether an incorrect distributor rotor has been installed. The distributor rotor (photo) must have a resistance value of 1 kOhm. Otherwise there can be fluctuations in idling speed.

Particularly when a distributor rotor with a resistance value of 0 Ohm has been installed.

Before any time-consuming troubleshooting work is begun (cold-running controller, pressure actuator, overvoltage protection relay, broken cable etc.), the distributor rotor should be checked.
