Bulletin

Opel Insignia Model year: 2009

Height adjustment system for seating defective

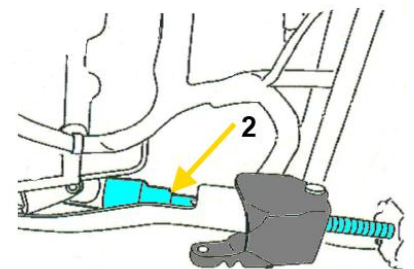
If the height adjustment system for the seating in the vehicle mentioned above no longer functions, it can be the fault of a blocked adjustment spindle.

The motor responsible for the adjusting of the seat height can jam between the spindle and the plastic stopper.

The problem can be solved with the help of an additional washer (1).

- Dismantle seat
- Loosen screw (2) and dismount
- Place washer (1) with the measurements 6.4 x 18 x 1.6 in position (OE No. 11035613)
- Lubricate with special grease (OE No. 13329237)
- Replace screw (2) and tighten with 10 Nm torque
- Remount seat
