Renault

All vehicles with engines: K4J, K4M, F4P, F4R, F5R

Engines stops

Bulletin

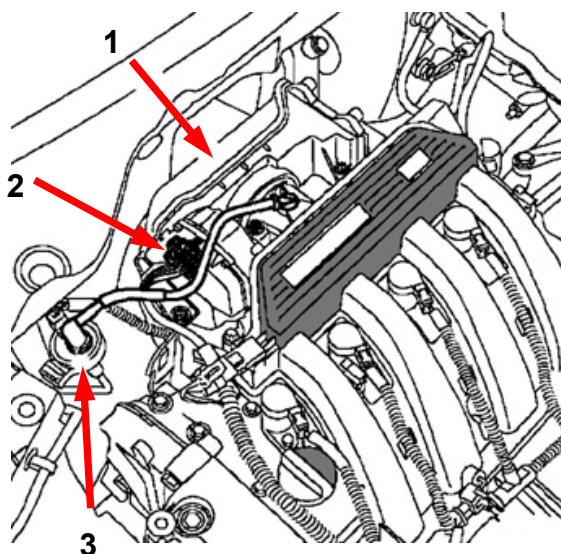
Fig. 1

If there are complaints about the above-mentioned fault, the cause could be the electric throttle-blade unit. Contamination of the throttle-blade unit can cause the above-mentioned fault. In this case, proceed as follows.

- Disconnect the battery.
- Remove the throttle-blade unit. To do this, dismantle the air-filter housing (see Fig. 1, 1).
- Disconnect the plug of the throttle-blade unit (see Fig. 1, 2), as well as the cable of the fuel-vapour recirculation system on the control valve (see Fig. 1, 3).
- Remove the fastening screws of the throttle-blade unit.
- Remove the upper and lower O-ring from the throttle-blade housing.
- Hold the throttle blade open by hand, and spray the housing from inside using a suitable cleansing agent (which is also offered by the manufacturer).
- After this, remove the loosened dirt using a rag (see Fig. 2).
- Use compressed air to blow away any residues.
- Refit removed parts in reverse order.
- Finally, the minimum and maximum stop of the throttle blade must be learned. This can be carried out using suitable diagnosis equipment.
