Renault Twingo up to model year 1999

Charging control lamp lights up faintly

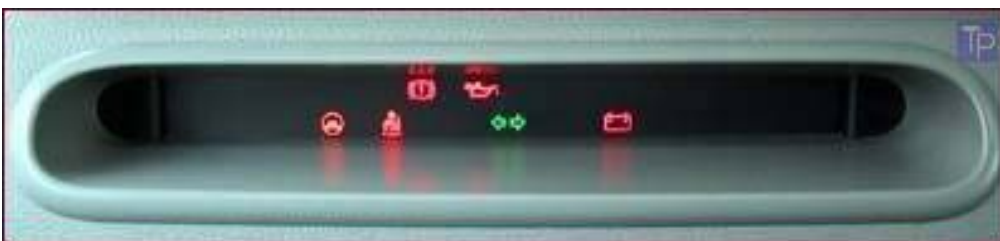
With the above-mentioned vehicles with a two-line instrument display (see photo) the charging warning lamp may light up faintly when the vehicle is idling. In this case the charging circuit must be checked. If this is OK, the instrument display panel must be replaced with a modified unit. To do this proceed as follows:

- Disconnect the battery
- Remove 2 screws for the display unit, behind the steering wheel, on the dashboard
- Remove the display unit from the dashboard
- Disconnect the plug
- Check the condition of the plug

Install the new instrument display panel in the reverse order to removal. Enter the radio code again if necessary and set the correct time on the clock.
