Rover 45 model year 1999 to 2004

Engine backfires

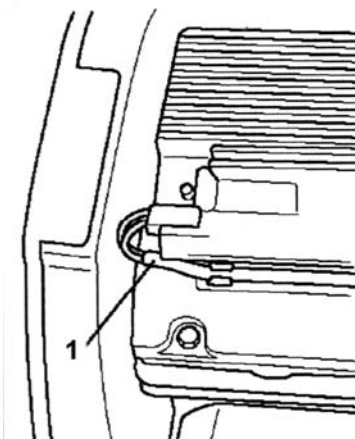
If there are complaints about the above-mentioned fault, incorrect routing of the coil wiring harness could be the cause. Apart from backfiring, the fault could also become noticeable due to delayed throttle response. This situation occurs particularly when the accelerator pedal is pressed more strongly (setting off, overtaking etc.). In Fig. 1 the wiring harness is jammed beneath the engine cover as can happen if the cover has not been fitted professionally. In this case unscrew the cover and route the wiring harness in the retaining clip in such a way that it doesn't jut over the edge of the valve cover (see Fig. 2).
