Saab 9-3 convertible Model year 1998–2000

Failure of the electric folding top.

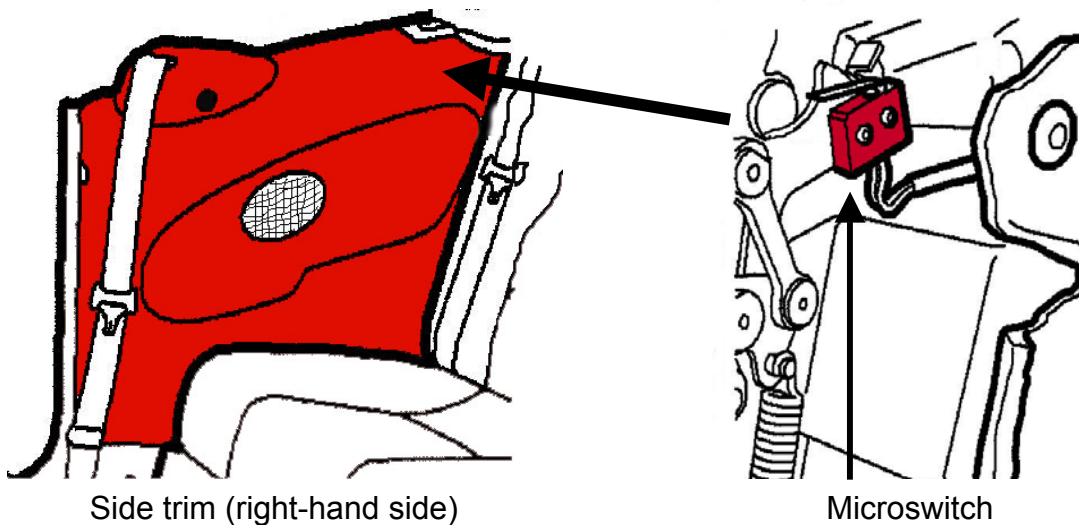
If there are complaints with these vehicles that the electric folding top is not working or stops when opening or closing, one possible cause is a defective microswitch for the folding-top lock. At the same time, fault codes B2025, B2026, B2030, B2031 may be stored in the fault memory. To eliminate the fault, the defective microswitch must be replaced. One microswitch is located on each side, on the right and left, behind the rear side trim. The rear side trim must be removed in order to replace the microswitch.
