# Bulletin

## VW Tiguan All vehicles of model year 2009

### Engine continues running after ignition is switched off.

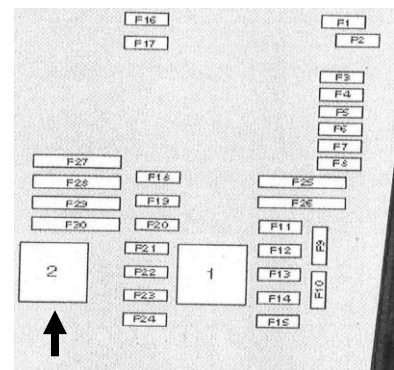
If complaints are made about these vehicles that the engine continues running even after the ignition has been switched off, a possible cause can be found with a defective relay 2 (engine control). The engine control unit - relay 2 is located in the fuse box / relay board (engine bay).

The relay is positioned in the fuse box as shown (See Figure 1 / Arrow).

It is possible that the fault code 00576 has been stored. This fault code refers to "supply voltage for drive circuit".

A modified relay is available to remedy this problem, with the following  
Spare part no.: 7 M0 951 253 A.

Please note: The relevant earth connections are also to be checked. Bad earth connections (varnish residues, corrosion etc.) can result in faults and malfunction or voltage problems in conjunction with the engine control unit.
