Mondeo, build 01.95 – 01.98

Speedometer temporary malfunction
or non function, automatic
transmission does not engage 4 th
gear.

Bulletin

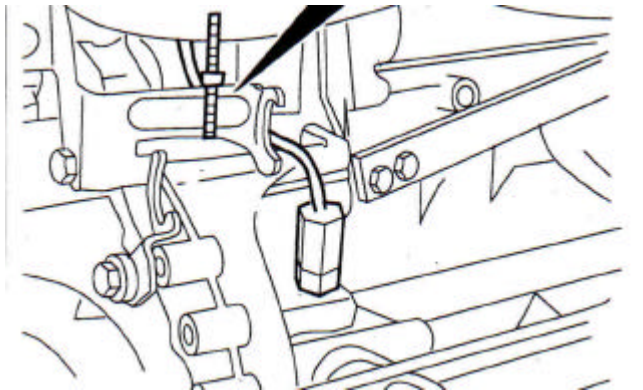
The cause of the problem is a broken drive shaft of the
vehicle speed sensor or a faulty wiring of the sensor.

1. Renew the vehicle speed sensor
2. Relay the wiring and secure it with cable ties
