## **BMW E34 520i 24V + 525i 24V (M50 engine)**

### **Defective oxygen sensor cable**

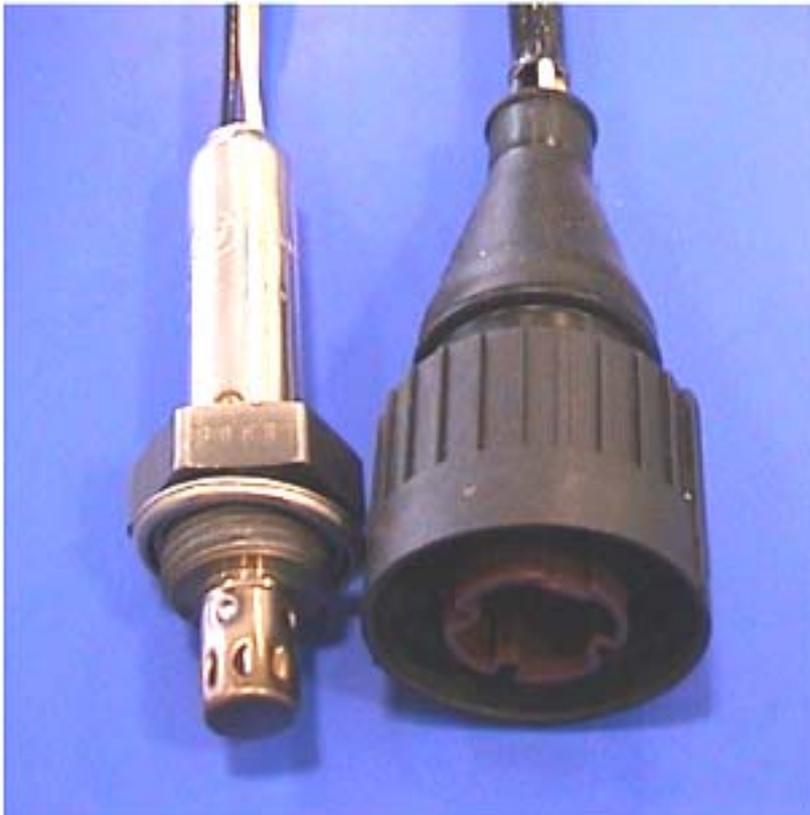
You can find suitable replacement sensors (photo) in the Hella oxygen sensor range.
