Bulletin

Citroen C3

Pluriel

**Model year: 2007-12-04 onwards (RPO 11348).
All models with electric power steering**

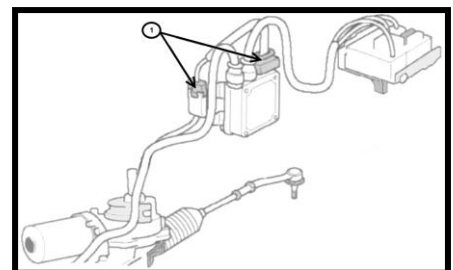
Sluggish electric power steering.

If it is reported that a large amount of effort must be expended to operate electric power steering for these vehicles, then the torque sensor for the electric power steering may be defective.

In order to analyse the source of the error and to rule out other causes of the malfunction, the electrical connections and the contacts for the wiring harness multi-plug have to be checked (see Figure/arrows). Furthermore, ensure that the plug connectors are firmly seated on the wiring harness connectors.

Check in advance whether error codes have been stored relating to the torque sensor for electric power steering.

If no malfunctions arise during the electrical analysis, then the gear rack for the electric power steering can be taken into consideration as the source of the error.
