Citroen C4 1,6 L HDI Engine codes 9HX, 9HY, 9HZ

Starting problems in cold weather

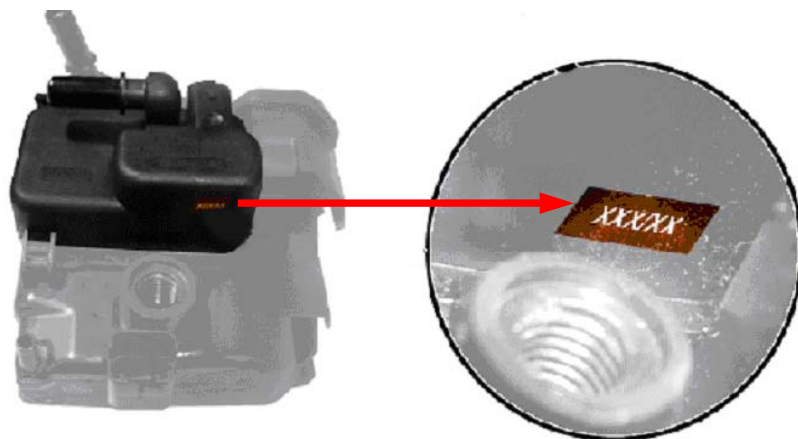
If there are complaints about the above-mentioned fault, the cause may be a defective fuel preheater. Due to the faulty preheater, the fuse for the built-in supply module blows. This fuse supplies the preheater and also the electrically operated valve for control of the turbocharger. In addition, two fault codes may be stored.

- Check the number engraved onto the preheater (see illustration).
- If the number is in the production period from 303/04 to 331/04, the preheater must be replaced (303 = production day, 04 = year)
- After this, replace the faulty fuse. This 30A fuse is in slot F10 in the fuse box / engine bay.

- Erase the fault memory and check that the system is working.
