Ford Ka, from model year 01.09.1996 Ford Fiesta, from model year 08.1995 to 09.2001, all with 1.3l Endura E engine

Increased idling speed when changing gear

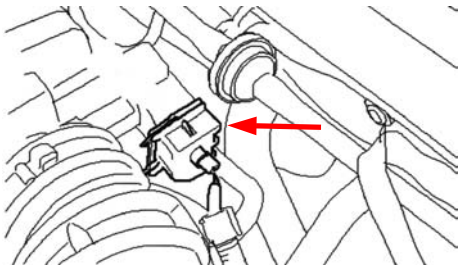
Fig. 1

If there are complaints about the above fault, the cause could be a defective throttle valve sensor connector. This fault causes implausible values to be sent to the control unit. In this case, the sensor, the connector and the cable loom (sensor cable) must be replaced. These spare parts are offered as a repair kit. Proceed as follows:

- Save the radio keycode and disconnect the battery.
- Remove the connector from the sensor (see Fig. 1)
- Remove the insulation from the cable loom (top of engine compartment, see Fig. 2). As the cable colours for the sensor can be found repeatedly in the cable loom (white cable 2x, brown-red cable 2x), the correct cables must be identified with the aid of a multimeter (continuity check, see Fig. 3).
 - Pin 1 yellow cable
 - Pin 2 white cable
 - Pin 3 brown-red cable
- Cut through the cables identified and strip the insulation from them.
- With the aid of CWT soldered connectors (Hella part number 8KW 744 888-003), connect the cable ends of the modified cable connector to the other cables (see Fig. 4).
