VW Golf IV from MY 08/1997 to 06/2006

Independent wiping or sporadic wiping movements of the front wiper

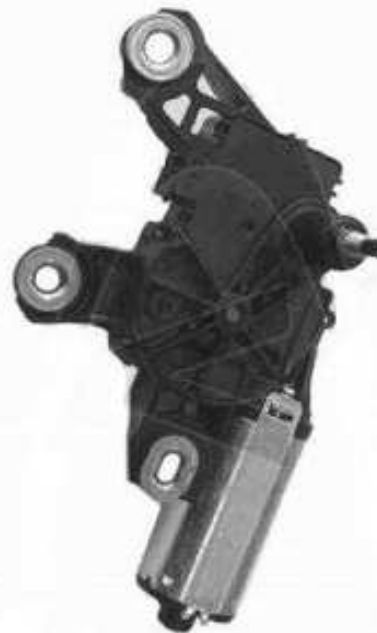
Note: The control board of the rear wiper motor could also be corroded through water penetration (leaky hose or washer system at the rear wiper motor) and thus make the front wiper carry out sporadic wiper movements. This is also applicable for vehicles that do not have a rain sensor.

Conclusion: If dripping washing water is noticed when the tailgate is opened or the tailgate trim is damp, the above-mentioned fault can be triggered by the corroded board on the rear wiper motor.

To eliminate the problem, remove the connector plug from the rear wiper motor and observe whether sporadic wiper movements still occur at the front wiper.

If the front wiper now works perfectly, the rear wiper motor must be replaced.
