Mercedes Benz W 170, 202, 203, 208, 210

Malfunction in the upper control panel of the centre console

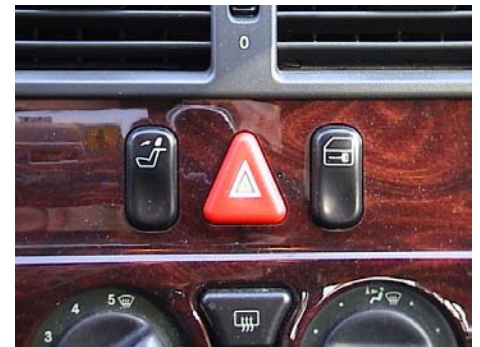
If there are complaints about the above-mentioned fault, the cause could be a poor electrical contact in the control panel (see photo). The eleven-pole coupling of the switch assembly (S6/1) in the control panel cannot be contacted properly. This can result in the seat heating function, the interior locking function, the hazard warning light system and the switch illumination being inoperative. A rib running around the edge of the coupling means that the central locating lug on the seat heating control unit (N25/5) pushes in front of the coupling, and thus prevents the correct locking in place and secure contacting of the switch assembly.

In this case, remove the control panel. Following this, disconnect the coupling and cut the central locating lug off the seat heating control unit. Reconnect the coupling and refit the control panel. Check the switch for correct function.
