## **Mercedes Benz ML 270 CDI Model year: 11.1999 - 06.2005 Engine: OM 612,963**

**Engine control light is on  
Vehicle in emergency running mode  
Error code: P1189 "intake duct  
shutdown"  
Engine power loss**

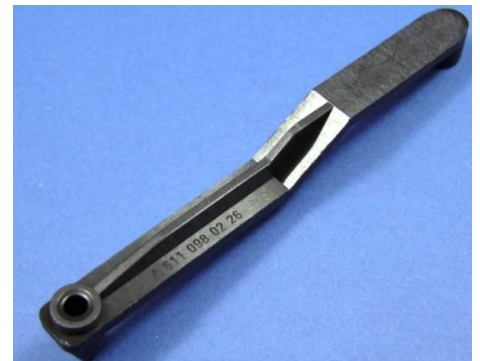
If one or more of the above problems are identified on this vehicle model, this may be associated with a broken linkage of the charge duct control. In this case, the linkage must be removed and replaced with a spare part modified by the vehicle manufacturer.

Mounting clip: 611 098 01 26

Linkage: 611 098 02 26
