Renault Megane and Scenic All vehicles with ESP

ESP warning light illuminates

Bulletin

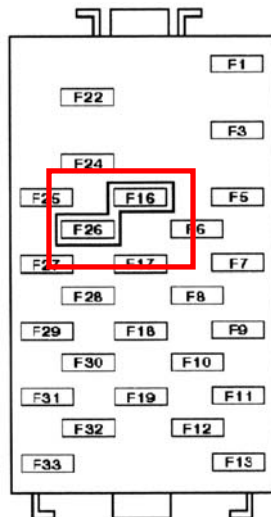
Fig. 1

If there are complaints about the above fault, the cause could be the battery voltage being too low when the engine is started. In addition, the fault code "steering angle sensor" is stored. In this case, proceed as follows.

- Remove the fuse box from the lower instrument carrier.
- Remove fuses F16 and F26 from the fuse carrier.
- With the aid of a shunt connector, connect the two slots together (see Fig. 1).
- Connect the fuses on the shunt connector.
- Refit the fuse box.
- Delete the fault memory.
