Saab 9-3

All vehicles with petrol engines

Model year 1998 to VIN W2061707

Engine has no power

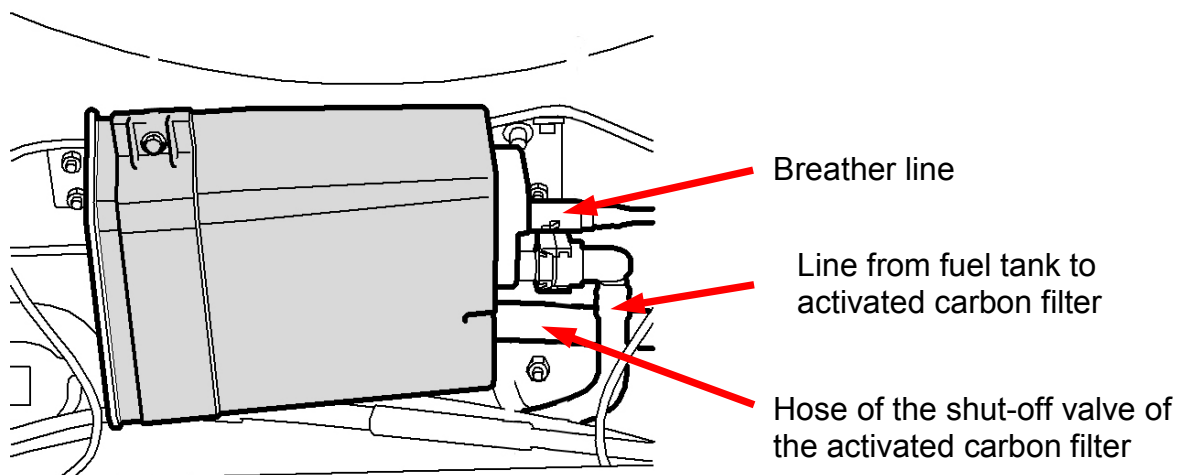
Due to faulty installation, the hoses can kink, and flow problems arise. In this case, the laying of the hoses of the activated carbon filter system must be checked and, if necessary, re-laid or replaced.
