## **Bulletin**

## Saab 9-3 Hatchback, model year 2000 until vehicle identification no.: Y2018486 Convertible, model year 2000 until vehicle identification no: Y7006098

## Poor engine running / Restricted ride comfort

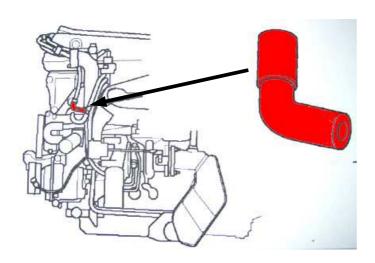
If there are complaints about the above-mentioned fault, the cause could be a defective hose piece. The angled hose (see illustration) on the T-piece, from the activated-carbon-filter solenoid valve (activated-carbon-filter canister purge valve) to the intake manifold, becomes brittle due to operational influences. In this case, the hose must be removed from the retaining clip and checked and, if necessary, replaced. The improved hose design is marked with a dotting-mark, directly next to the part number, on the thick end of the hose.
