Ford Galaxy 1,9 L TDI from 11/97 Water penetrate into the left headlamp

Spray water penetrates into the left headlamp after heavy rain.

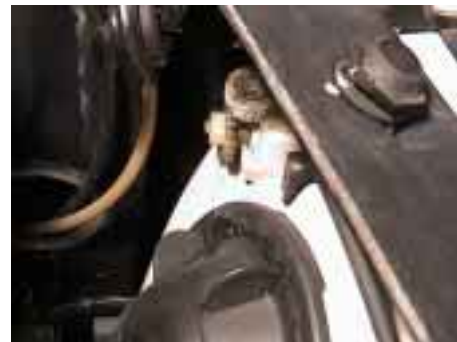
Fig. 1

During heavy rains it is possible, that the road spray through the ventilation fan penetrates into the headlamp (Fig. 1) This circumstance is shown through heavy misting inside the headlamp (waterdrops form and run on to the inner casing). To rectify this fault, Ford offer a retrofit-kit. This kit contains a modified vent hose and a special cover protecting against the road spray.
