## *VW Golf '98 TDI flickering headlight*

Bulletin

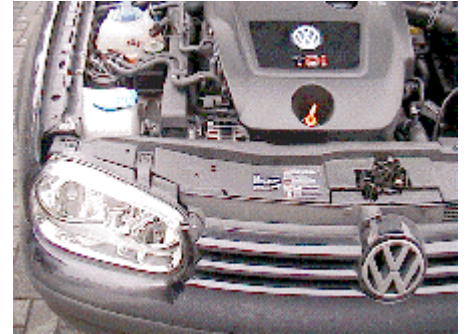
After the cold starting the headlights dim and brighten frequently

At engine temperatures  $< 20^{\circ}\text{C}$  the glow plugs are additionally switched on up to 2500 rpm. The emissions and diesel knock are reduced through this operation. As a result of the increased load on the generator (high generator voltage), at low rpm, the generator voltage drops by about 2 volt. Due to this surging voltage the light appears to flicker dim and bright. This situation is only apparent for a short time during the warm up phase.

No changes are being considered in series, because the power of the battery and the generator are considered to be sufficient.

The charging current of the battery and the power of the generator should nevertheless be checked. In addition the occurrence should be explained to the customer to prevent complaints.
