Audi A3 with xenon light Model year from 1997 to 2003

Headlight range adjustment (LWR) does not work correctly

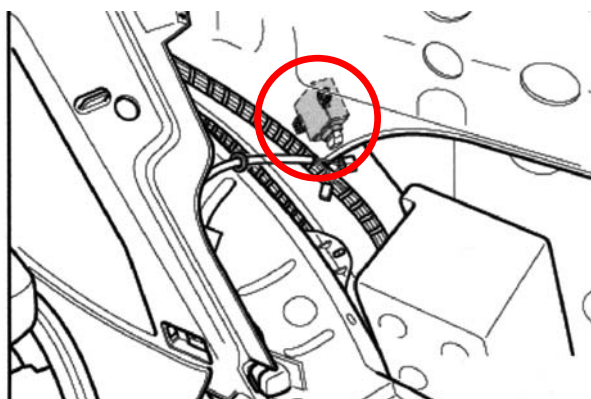
Fig. 1

On the 3-door version, the LWR control unit is on the wheel housing on the left under the side panelling, (see Fig. 1). On the 5-door version, the control unit is

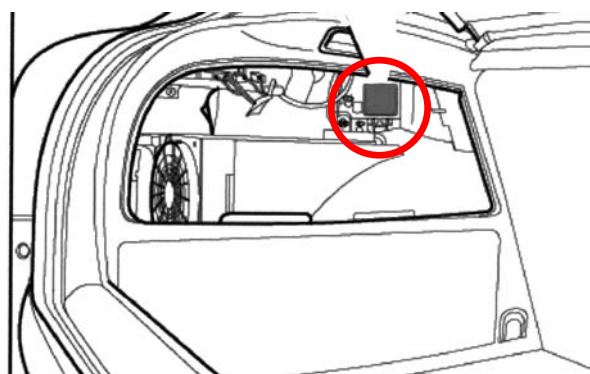
Fig. 2

in the boot, installed on the left under the side panelling (see Fig. 2).
