## **BMW** **3 series (E46)** **All vehicles with Xenon lights**

### **Failure of the headlight range adjustment**

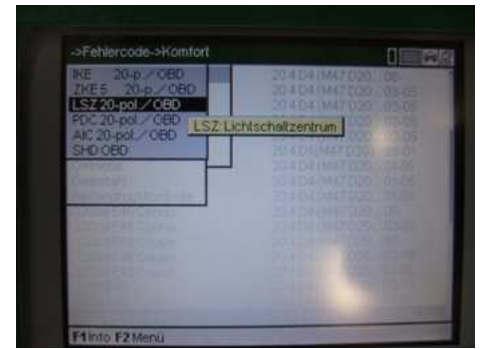
Fig. 1

1. Read out the fault code with an appropriate diagnostic tester. For this purpose, select the "Lichtschaltzentrum" (light switching centre) menu item after selecting the vehicle (see Fig. 1).
2. In this case, a faulty power supply on the front vehicle level sensor will be detected (see Fig. 2).
3. Now check the actual values of the sensor under the "Messwerte und Parameter" (measured values and parameters) menu item. The value for the front sensor (load sensor) will be 0.2 volts, which is much too low. Also, the value will not change by simulating a change in the vehicle level.
4. Raise the vehicle and check the connector and wiring of the sensor for damage and corrosion. If no problems can be found, an internal fault in the sensor must be assumed.
5. Replace the vehicle level sensor. **Recommendation:**

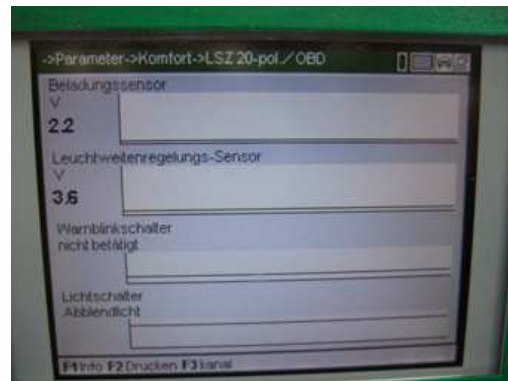
Fig. 3

6. After replacing the front sensor, its value will be 2.2 volts, which is in the nominal range (see Fig. 3).
7. Tune the vehicle's suspension and adjust the headlights according to the manufacturer's instructions.
