Citroen Berlingo Model years 2002-2008

Failure of the low beam

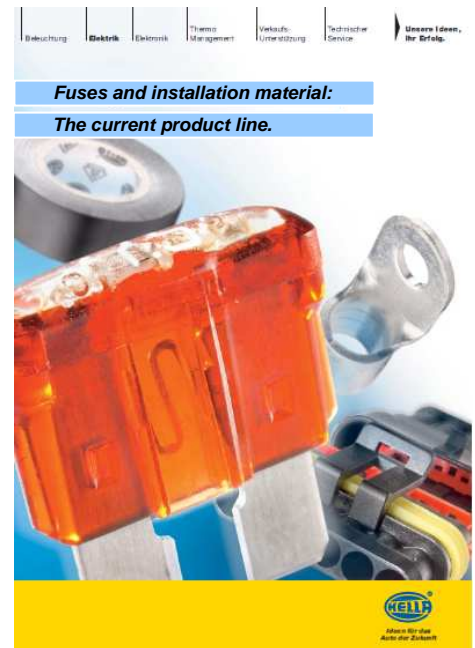
If a customer complains about the above problem, this could be caused by a frayed cable harness. Additionally there may be electrical failures/malfunctions. The cable harness runs from the fuse box in the engine compartment (front left) through a passage opening in the wheel arch to the headlamps. Since the cable is not protected at this opening, it may become frayed here due to vibration. This then leads to the above-mentioned problems. In this case, the damaged areas on the cable must be repaired. Then protect the cable harness in the area of the passage hole with a corrugated pipe in order to avoid repeated chafing. Below is a summary of corrugated pipes. For details on installation material, refer to Hella Bulletin with order 9Z2 999 029-115.
