Citroen

Xsara Picasso

All models from 2005 - 2011

Direction indicator switch does not reset automatically.

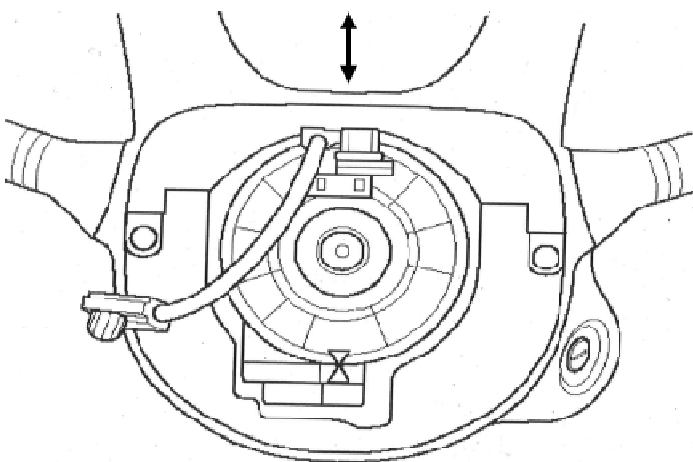
In case of complaints on these vehicles that the direction indicator switch (direction indicator stalk - automatic reset mechanism) does not reset automatically, an incorrectly installed / positioned coiled spring in the steering wheel may be the cause. To rectify this problem it is to be checked that the electrical connection on the coiled spring in the steering wheel is at the "12 o'clock position" (see figure). If not, place coiled spring in the correct position.
