Fiat Punto II, Typ (188)

Condensed water in the headlamp

Bulletin

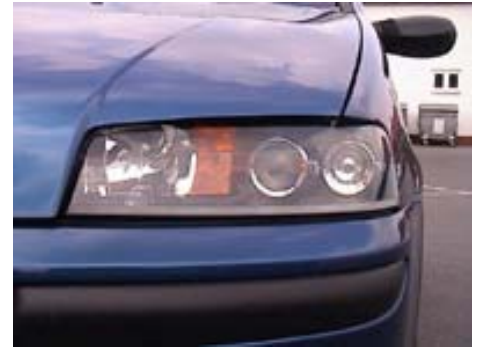
If the above mentioned failure is queried, the cause could be bad ventilation inside the headlamp. This can be recognized by, condensation collecting inside the head lamp and runs as waterdrops down the lens. In this case on both headlamps the bulb cover and the fastening clamps must be replaced. Retrofit sets are available (with and without fog light). These contain revised covers with ventilation holes and the corresponding clamps.

Before installation, any visible condensation should be removed with a hair-dryer. Pay attention when mounting the new cover, that the ventil points downwards.
