## VW Golf V

### LED – tail light/hazard warning light without function

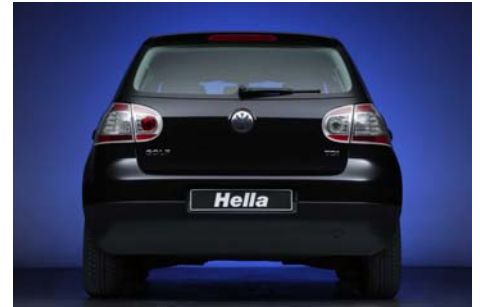
Fig. 1

If there are complaints with above-mentioned vehicle models equipped with the Hella LED tail light 2VP 009 500-801 (silver/red, see Fig. 1), that the hazard warning light does not work, the problem could be caused by a modified onboard electronics system. In some cases, when the engine is switched off and the hazard warning light activated, the function of the hazard warning light is not guaranteed. From model year 2006 (week 22, 2005), the onboard electronics of the Golf V were changed by the vehicle manufacturer. Modified sets are expected to be available from week 17/06. The following regulation applies for vehicles which already have these lights fitted:

The version 2VP 009 500-831 (silver/black) will be delivered from SOP in week 17/06 with the updated LED-PCB.

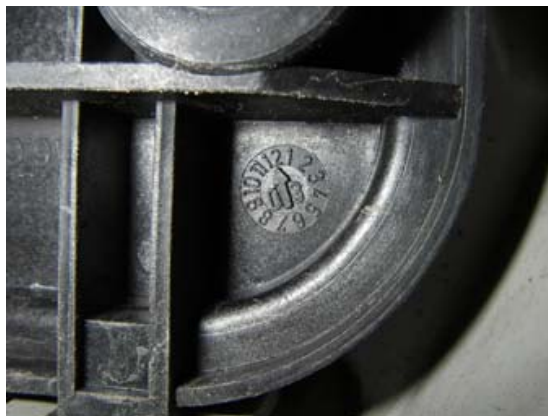
Fig. 2

- The problem does not occur with vehicles built before week 22/2005. The date of manufacture is on the rear of the light (see Fig. 2).
- From model year 2006 (with roof aerial) the LED lights will be replaced free of charge by the modified version if complaints are received from customers.
