VW Golf III Cabrio and Golf IV

Condensation in headlamps

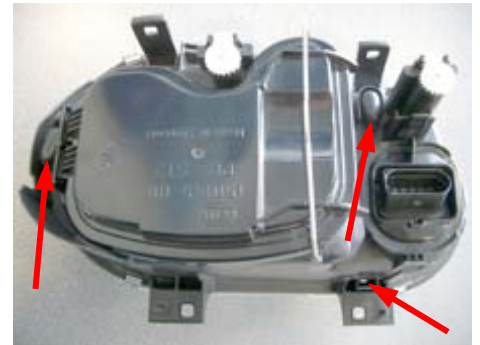
If there are complaints about the above-mentioned problem, the ventilation openings and/or damaged seals on the headlamp cover could be the cause. Air circulation must be guaranteed in the headlamp for physical reasons. This is achieved by means of the ventilation openings. Yet in the cold/damp seasons in particular, the high level of humidity in the headlamps can lead to the cover lenses becoming fogged. This fogging usually evaporates again very quickly when the low beam is switched on. If the humidity level is too high, however, the fogging condenses to water drops. The dust filters in the ventilation openings must be removed to improve circulation in the headlamps. Headlamps built since May 1998 no longer have these filter inserts.

- Check the cover cap seal for damage.
- Remove the ventilation covers (see photo)
- Remove the filter inserts with the aid of a screwdriver or wire.
- Remount the ventilation covers.
