VW T6 - replacing the differential pressure sensor

Data sheet	
Manufacturer	Volkswagen
Vehicle model	Transporter T6
Engine	2.0-litre Diesel
Engine code	CXHA
Year of manufacture	2015 - 2019
Symptoms	Replacement of differential pressure sensor

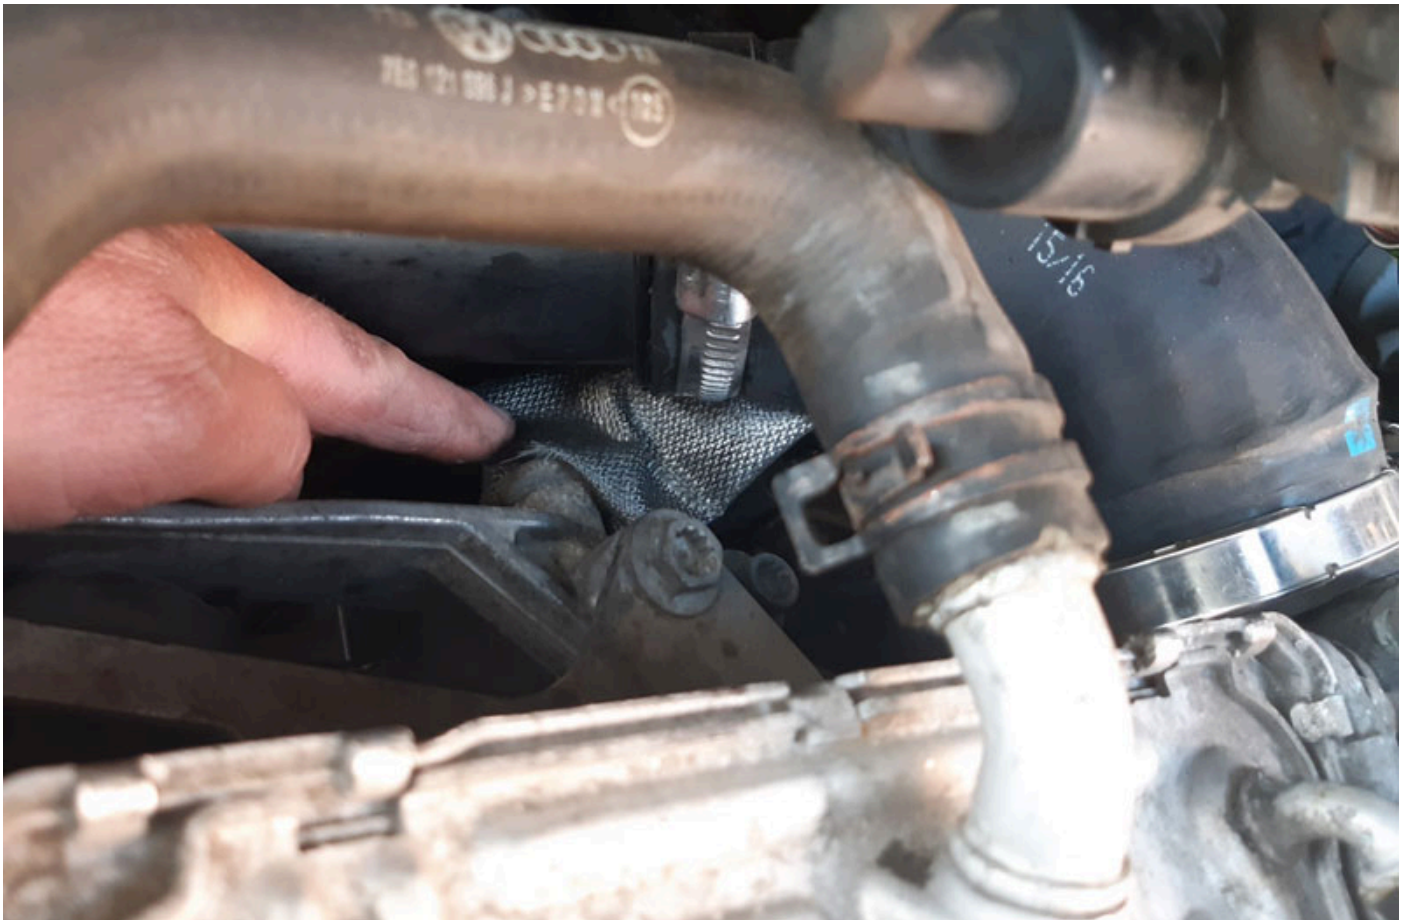
The sensor, wrapped in heat protection foil, is located behind the hose of the charge air cooler, as shown in ([Fig. 1](#)). In order to access the sensor, the charge air hose or the charge air pipe has to be removed as seen in ([Fig. 2](#)). This is done by removing 2 screws in the lower section. Loosen the hose clip at the top of the charge air cooler([Fig. 3](#)). Now it will be possible to remove the hose/pipe combination ([Fig. 4](#)). After opening/removing the heat protection foil, the sensor becomes visible. It can now be replaced with a sensor, for example, from HELLA (Part no: 6PP 009 403-221).
