# Lancia Ypsilon - Display for outside temperature | HELLA

**Lancia**

**Ypsilon**

## **Air-conditioning system/Display for outside temperature**

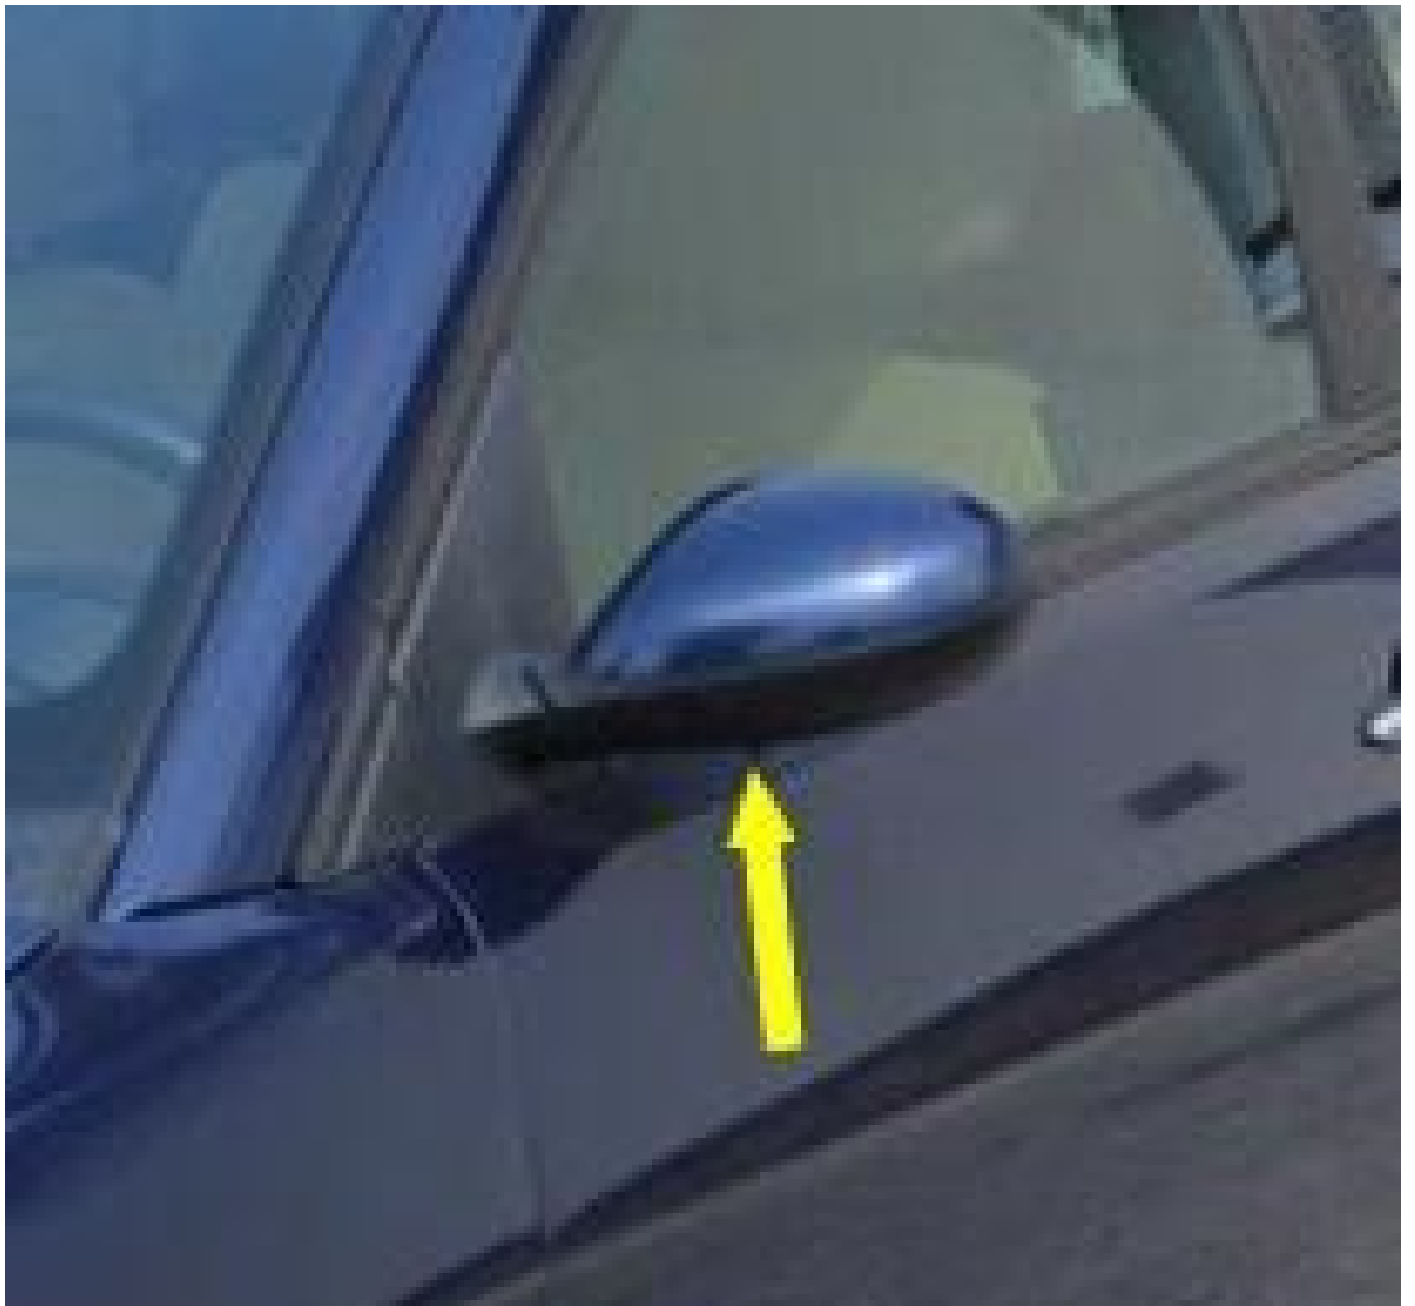
The vehicles mentioned above may experience a failure of the display for outside temperature. This affects the control of the air-conditioning system.

The outside temperature sensor is housed in the left-hand wing mirror (see figure). A broken cable in the mirror can cause a failure in the temperature display.

This leads to control problems when using the air-conditioning system.

We should proceed as follows to rectify the problem:

- Remove the rear cap from the mirror
- Remove the actuator motor
- Remove the mirror cover
- Dismantle the mirror housing
- Locate and repair the damaged part of the wiring harness
- Perform a functional test
- Re-assemble the mirror
