# Land Rover Range Rover IV - airbag indicator lamp on

Data sheet	
Manufacturer	Land Rover
Vehicle model	Range Rover IV (LG)
VIN	LG000001 – LG118277
Year of construction	2013 - 2014
Symptoms	Airbag indicator lamp lights up. Various error codes relating to the airbags can be set.

# Land Rover Range Rover IV airbag indicator lamp is on and fault or error codes relating to the airbags can be set.

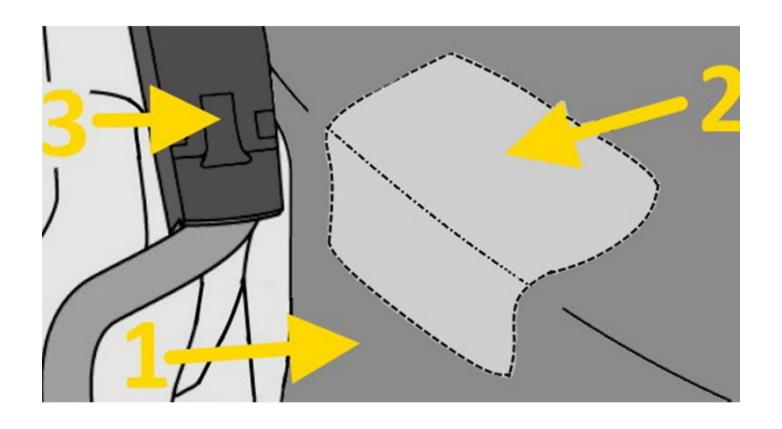
If the above-mentioned problem is detected, one possible cause may be <shy /> a faulty or loosened plug connection for the side airbag.

In such a case, constant contact between the plug connection of the side airbag (<span class="gallery-mode--link" data-order="1">Picture 1 position 3</span>) and upholstery of the seat backrest (<span class="gallery-mode--link" data-order="1">Picture 1 position 1</span>) is responsible for the above-mentioned problem.

Picture 1: Permanent contact between the plug connection of the side airbag and the seat backrest upholstery

- Dismantle cover of the seat backrest
- <strong>Define the marked area (<span class="gallery-mode--link" data-order="1">Figure 1
  position 2</span>) of the seat backrest upholstery</strong>
- <strong>(<span class="gallery-mode--link" data-order="1">Figure 1 position1</span>) and cut it out with a suitable tool (e.g. a cutter knife)</strong>
- <strong>Check plug connection (<span class="gallery-mode--link" data-order="1">Figure 1
  position 3</span>) for correct fit</strong>
- Position the plug connection in the cut-out area
- <strong>(<span class="gallery-mode--link" data-order="2">Figure 2 position 4 and 5</span>)
  and fix, ensuring connection is relieved of strain
- Fit cover on seat backrest
- Unlock the airbag system

This should be followed by an error code query using a suitable diagnostic unit (delete error memory if necessary) and a test drive to check the repair measures should also be carried out.

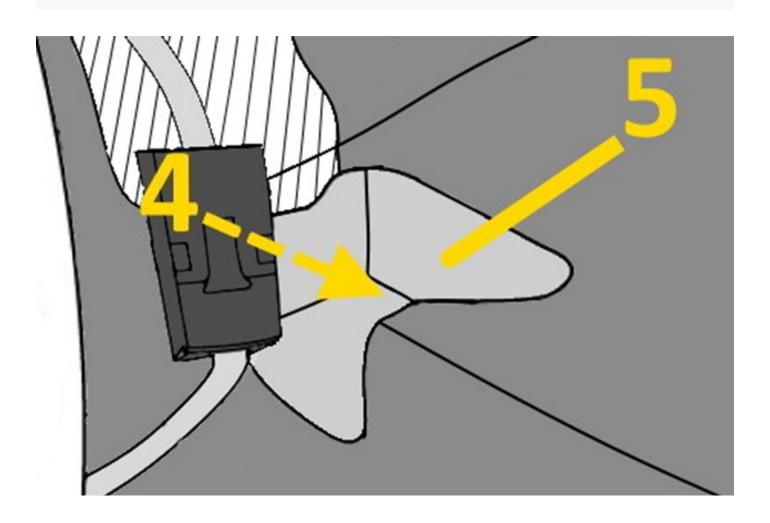
#### Picture 2: cut-out area in the seat backrest upholstery
