# Lexus GS300/GS350 - Condensation drain | HELLA

**Lexus**

**GS300/GS350**

## **Condensation drain**

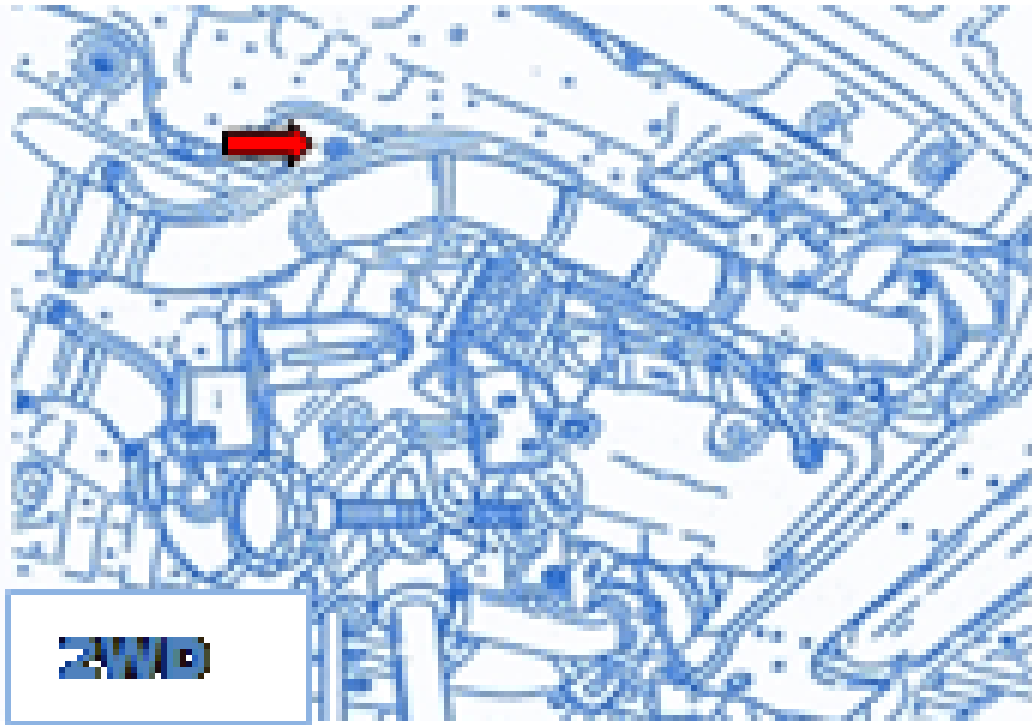
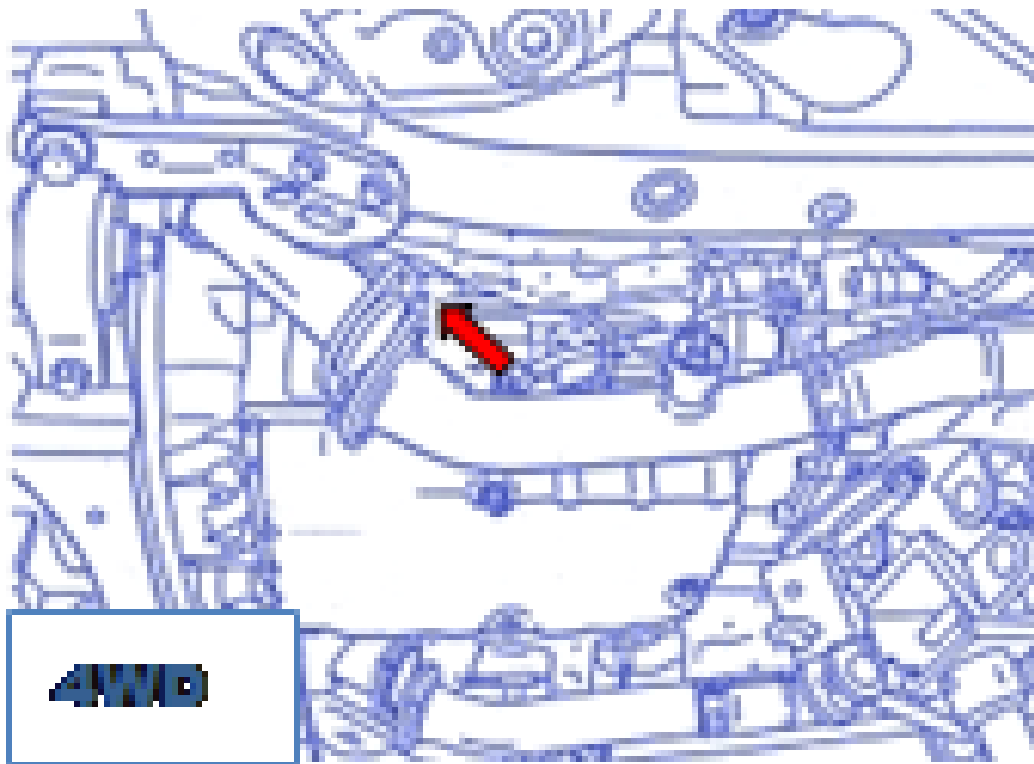
On the above vehicles, a blocked condensation drain in the air-conditioning system can lead to an ingress of water in the vehicle interior.

You can see the condensation drain if you stand on the transmission side and look at the vehicle undercarriage, above the transmission (see drawings).

- Lift the vehicle up using a lifting platform
- Clip out the electrical cable for the O2 sensor
- Unscrew the exhaust from each part of the Y-pipe and prop up
- Remove the transmission support and prop up the transmission
- Remove the front drive shaft (all-wheel drive only)
- Lower the transmission a few centimeters
- If necessary, remove the gear lever

You can now clean the grommet for the condensation drain using a long, blunt object or replace it with a modified version. For more information, please contact your authorized dealer.
