# Coolant pumps | HELLA

## General

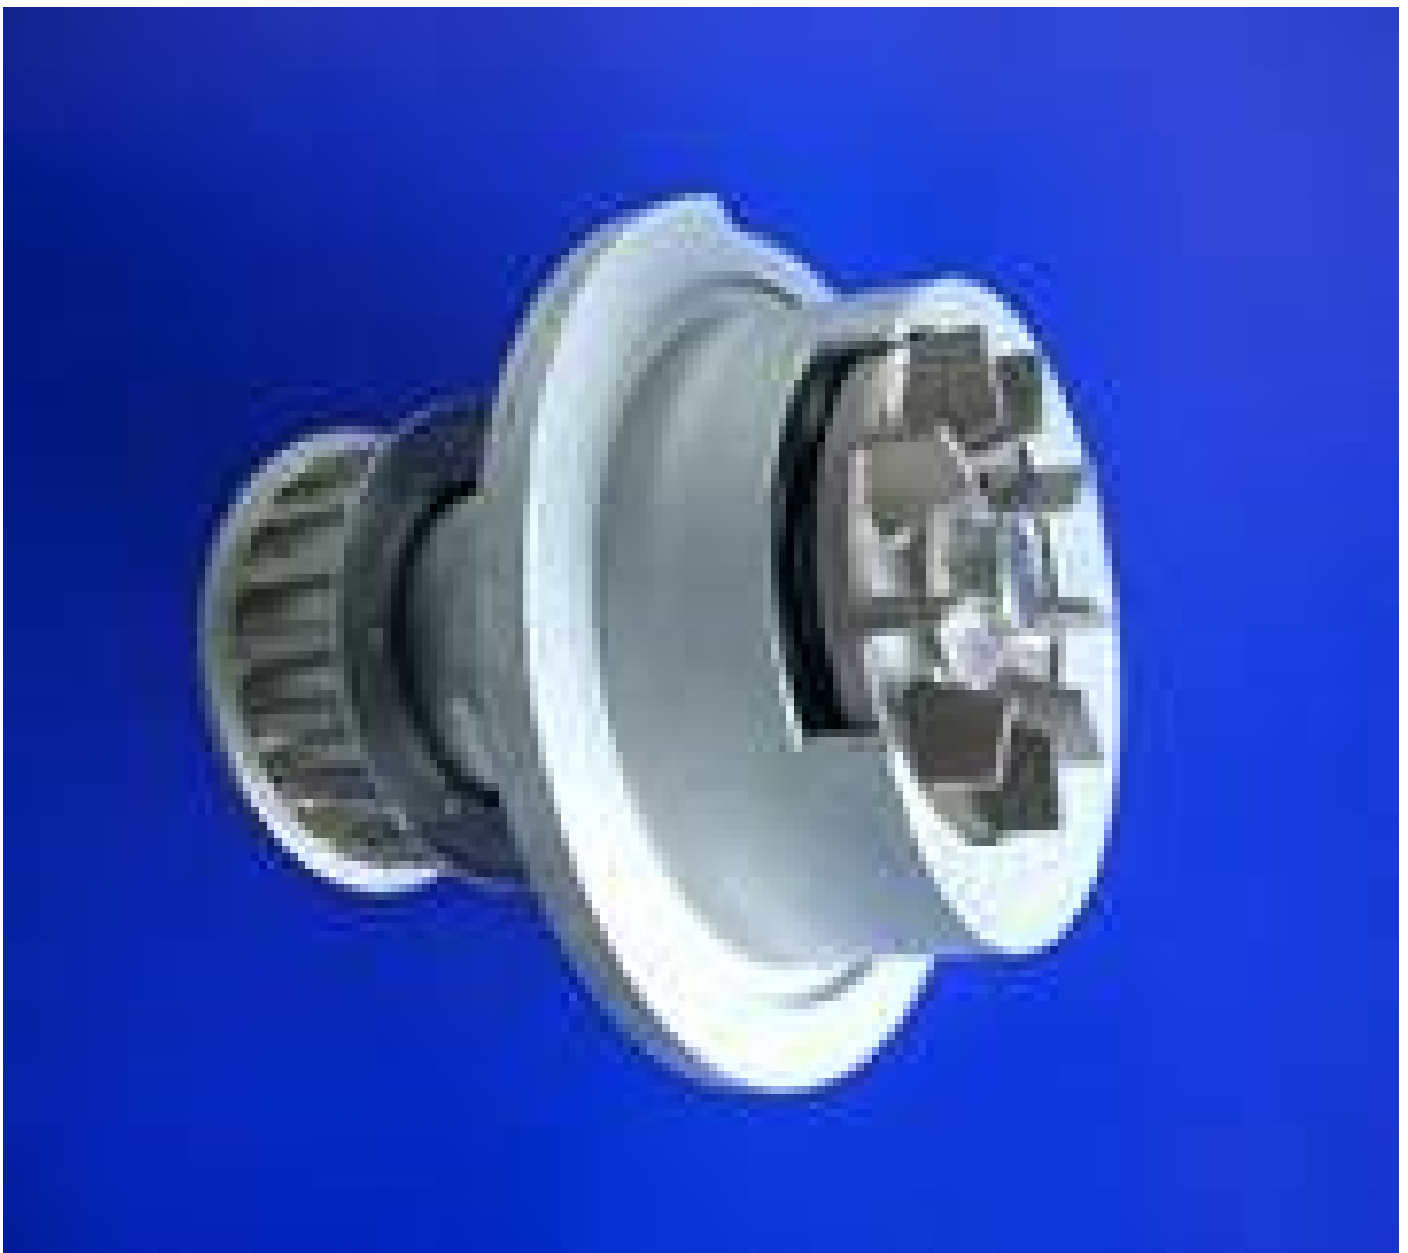
Figure 1

Coolant pumps (Figure 1) are mostly driven mechanically, by a toothed belt or V-ribbed belt, and transport the coolant through the engine's coolant circuit. The pumps can be flanged directly to the engine or also installed away from it. The designs are quite different. Coolant pumps must withstand huge variations in temperature (-40 °C to approx. +120 °C). Changing speeds (500 - 8000 rpm) and pressures of up to 3 bar require high stability of bearings and seals.

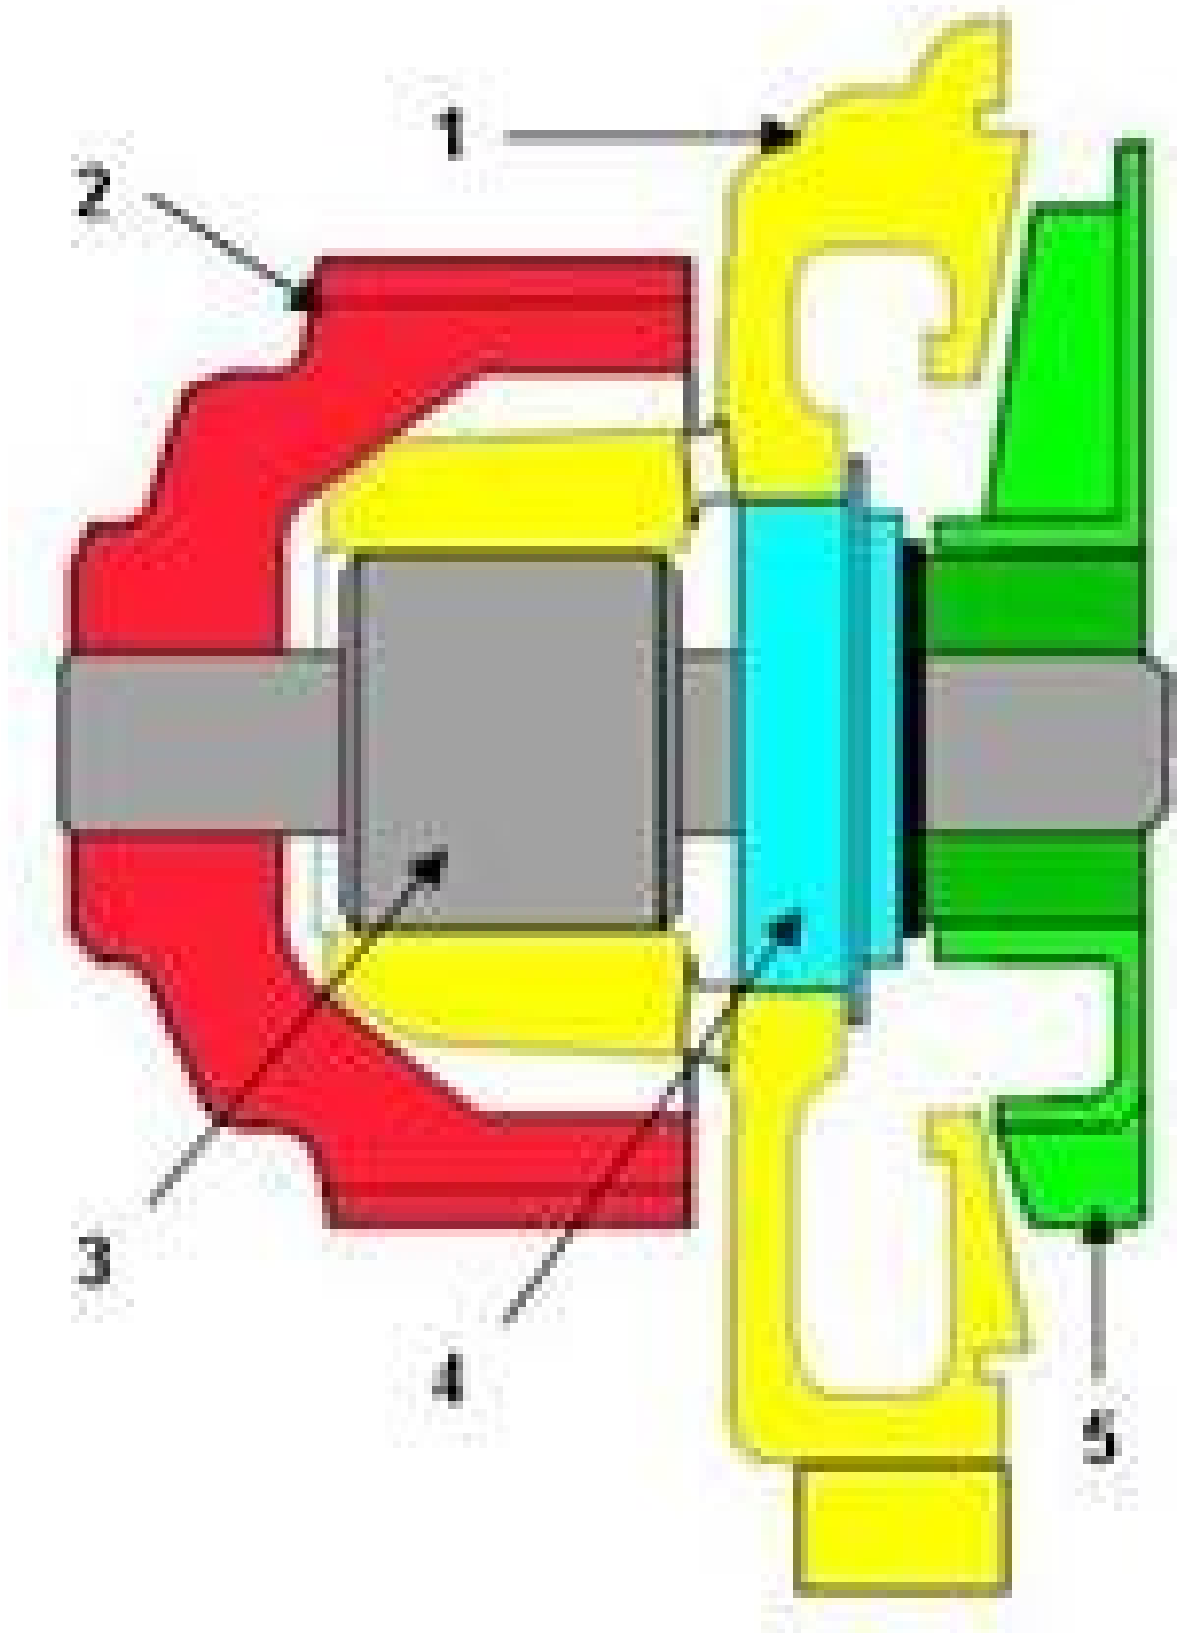
Drawing

A mechanical coolant pump consists of the following 5 sub-assemblies (drawing):

1. Body
2. Drive gear
3. Antifriction bearing
4. Mechanical seal
5. Vane

The drive gear and the vane sit on a common shaft. A mechanical seal seals off the pump shaft towards the outside. The rotation of the vane transports the coolant through the cooling system. Vanes are usually made of plastic or metal. The bearing load is lower with plastic vanes. At the same time, they are not as susceptible to cavitation.

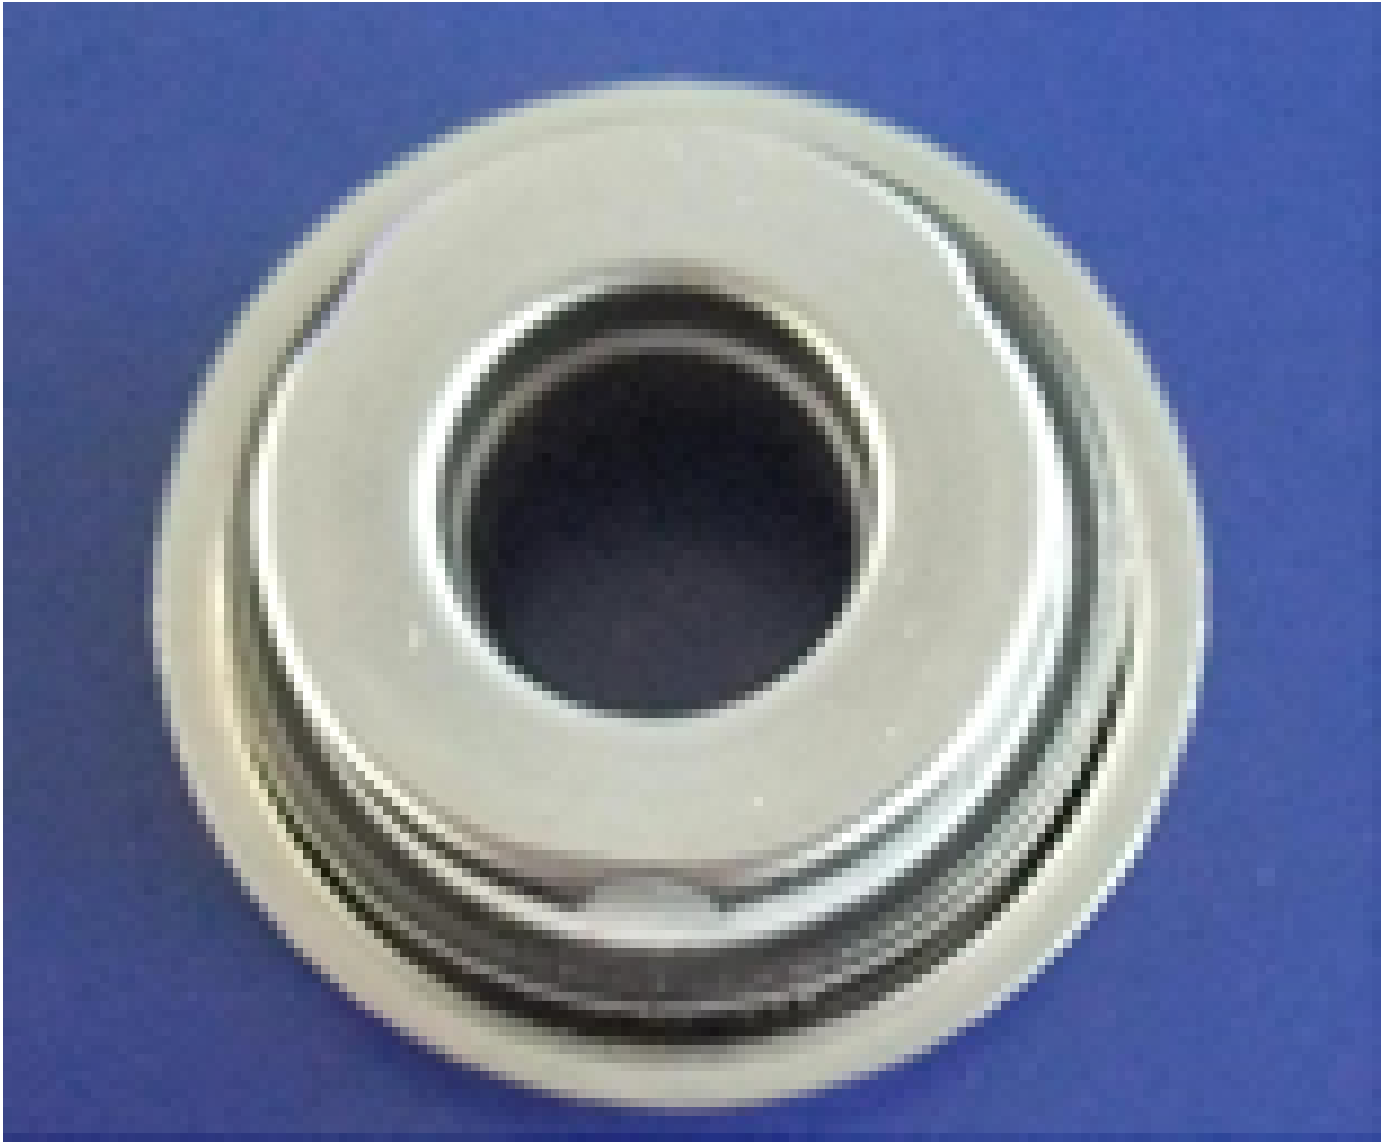
Figure 2

The mechanical seal (Figure 2) is always lubricated and cooled by the coolant. Due to the design, minimal amounts of coolant can enter the space behind the seal and exit at the relief hole of the pump. Traces of coolant that may be visible are no clear indication of a defective pump.

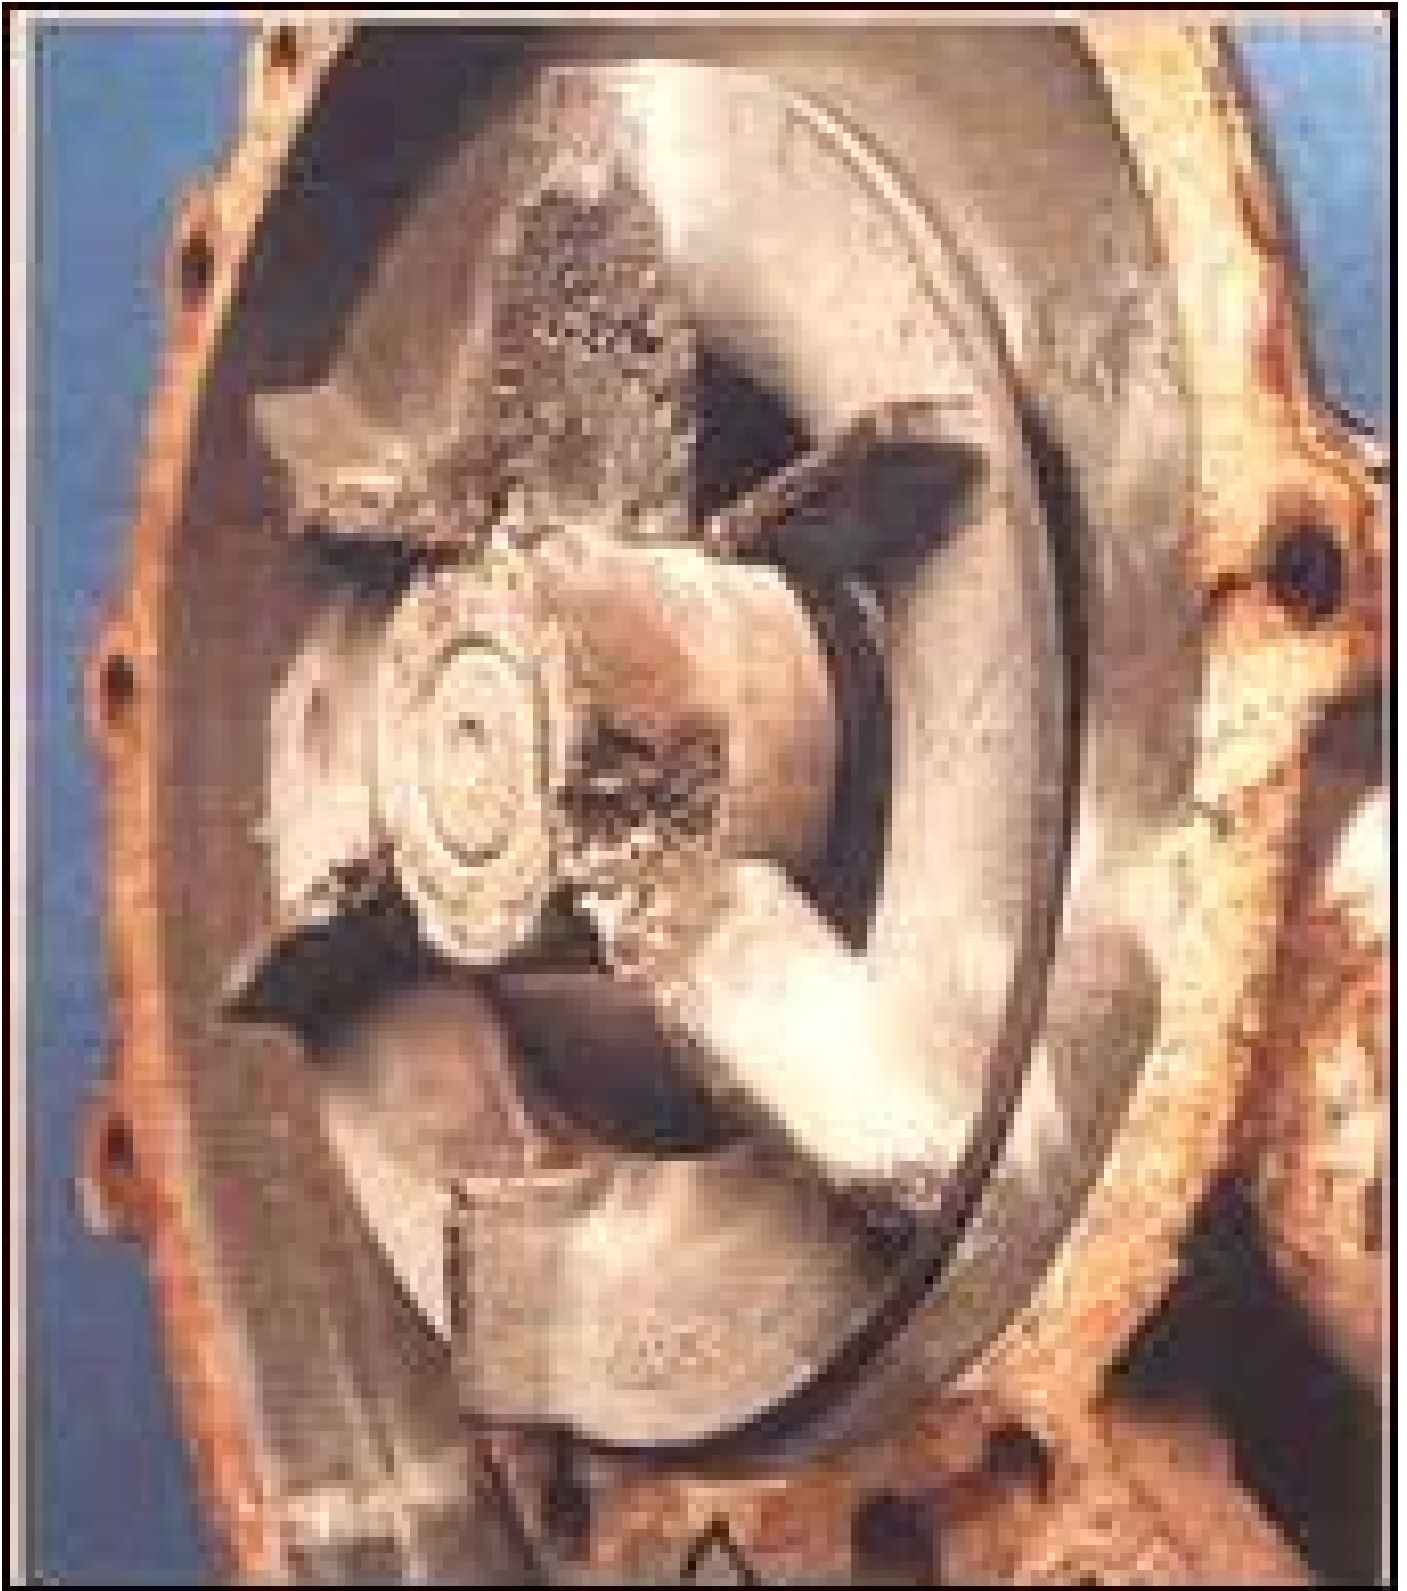
Figure 3

- Mechanical damage: Loose/broken vane Bearing or seal broken Drive gear damaged
- Cross-section constricted by corrosion or sealant
- Cavitation: Damage to the vane by the forming and collapsing of vapour bubbles in the coolant (Figure 3)
- Electrical fault (short-circuit/interruption)

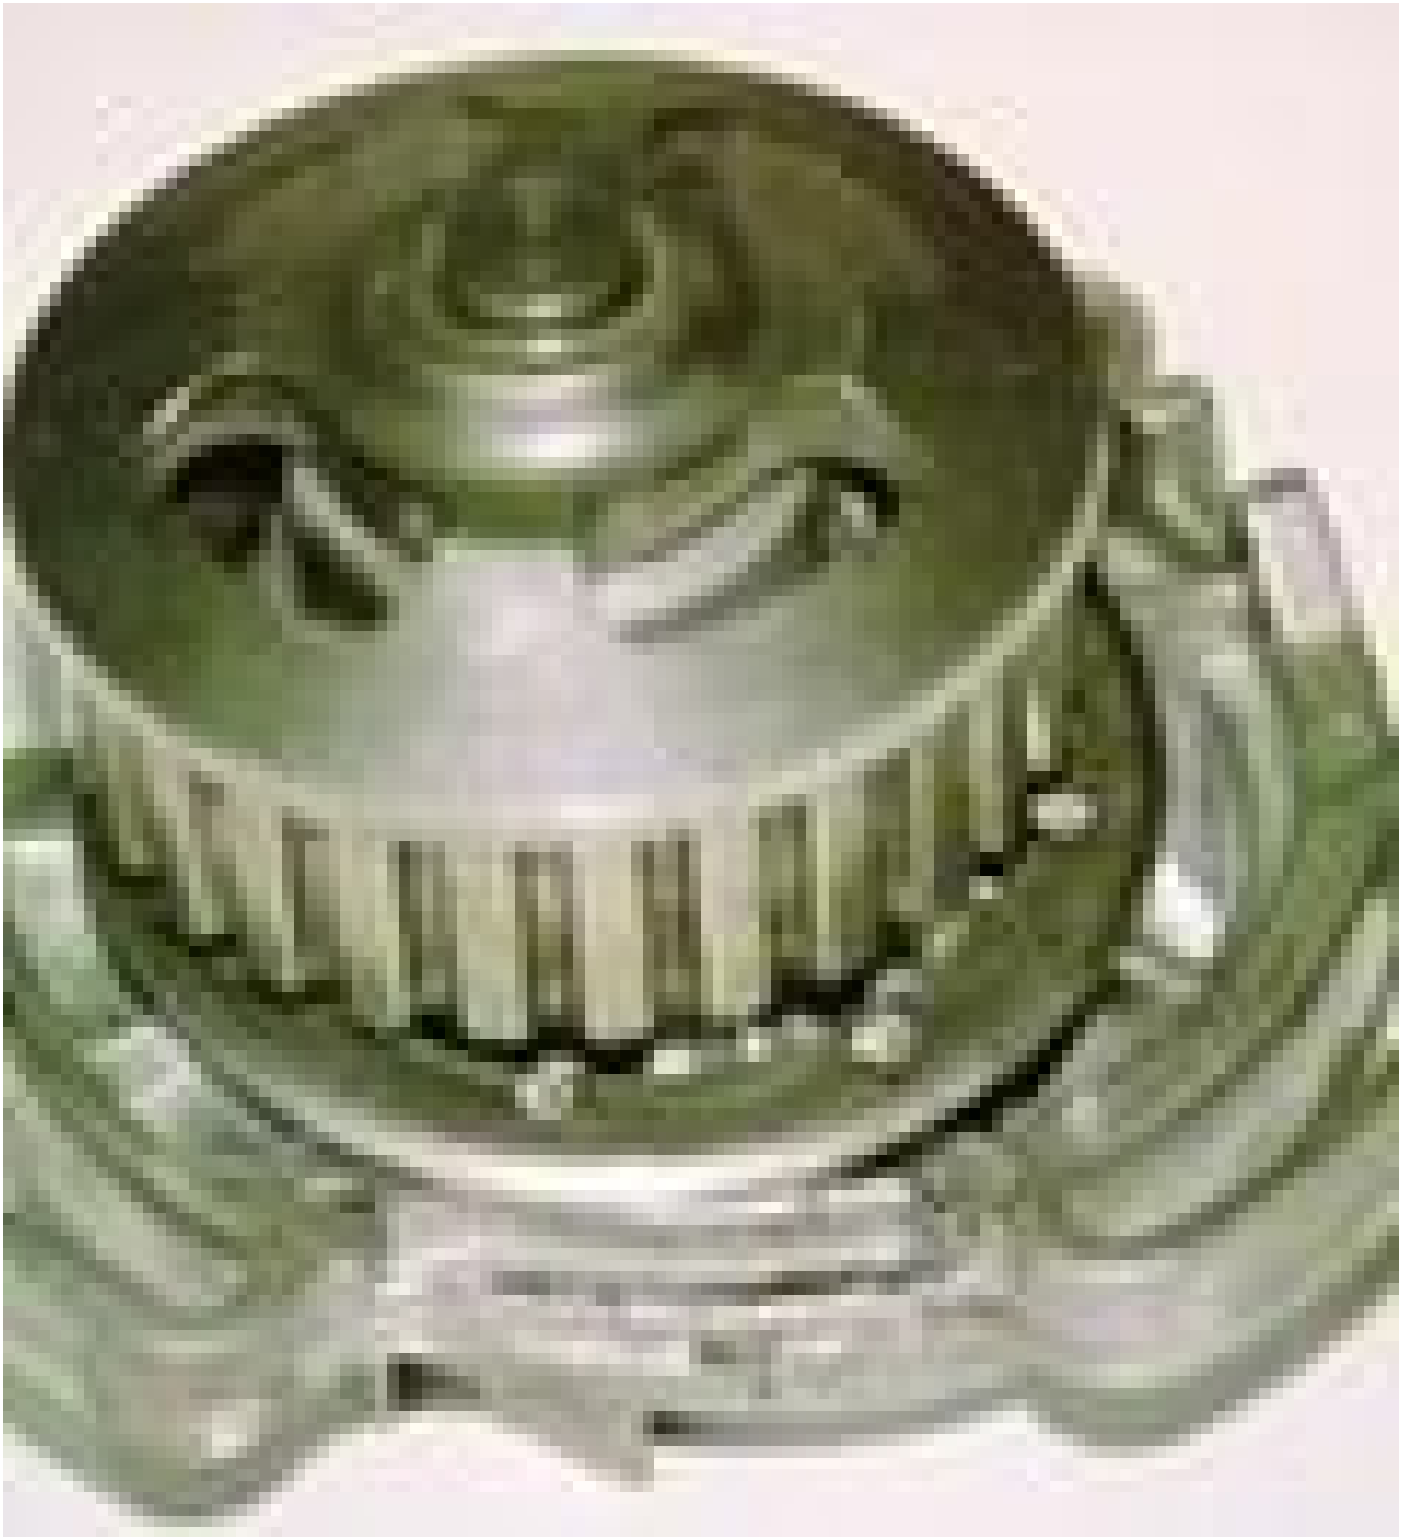
Bild 4

Drive gear damaged (loose drive gear ring), Figure 4:

- tension of the control belt too high

- Misalignment of the belt

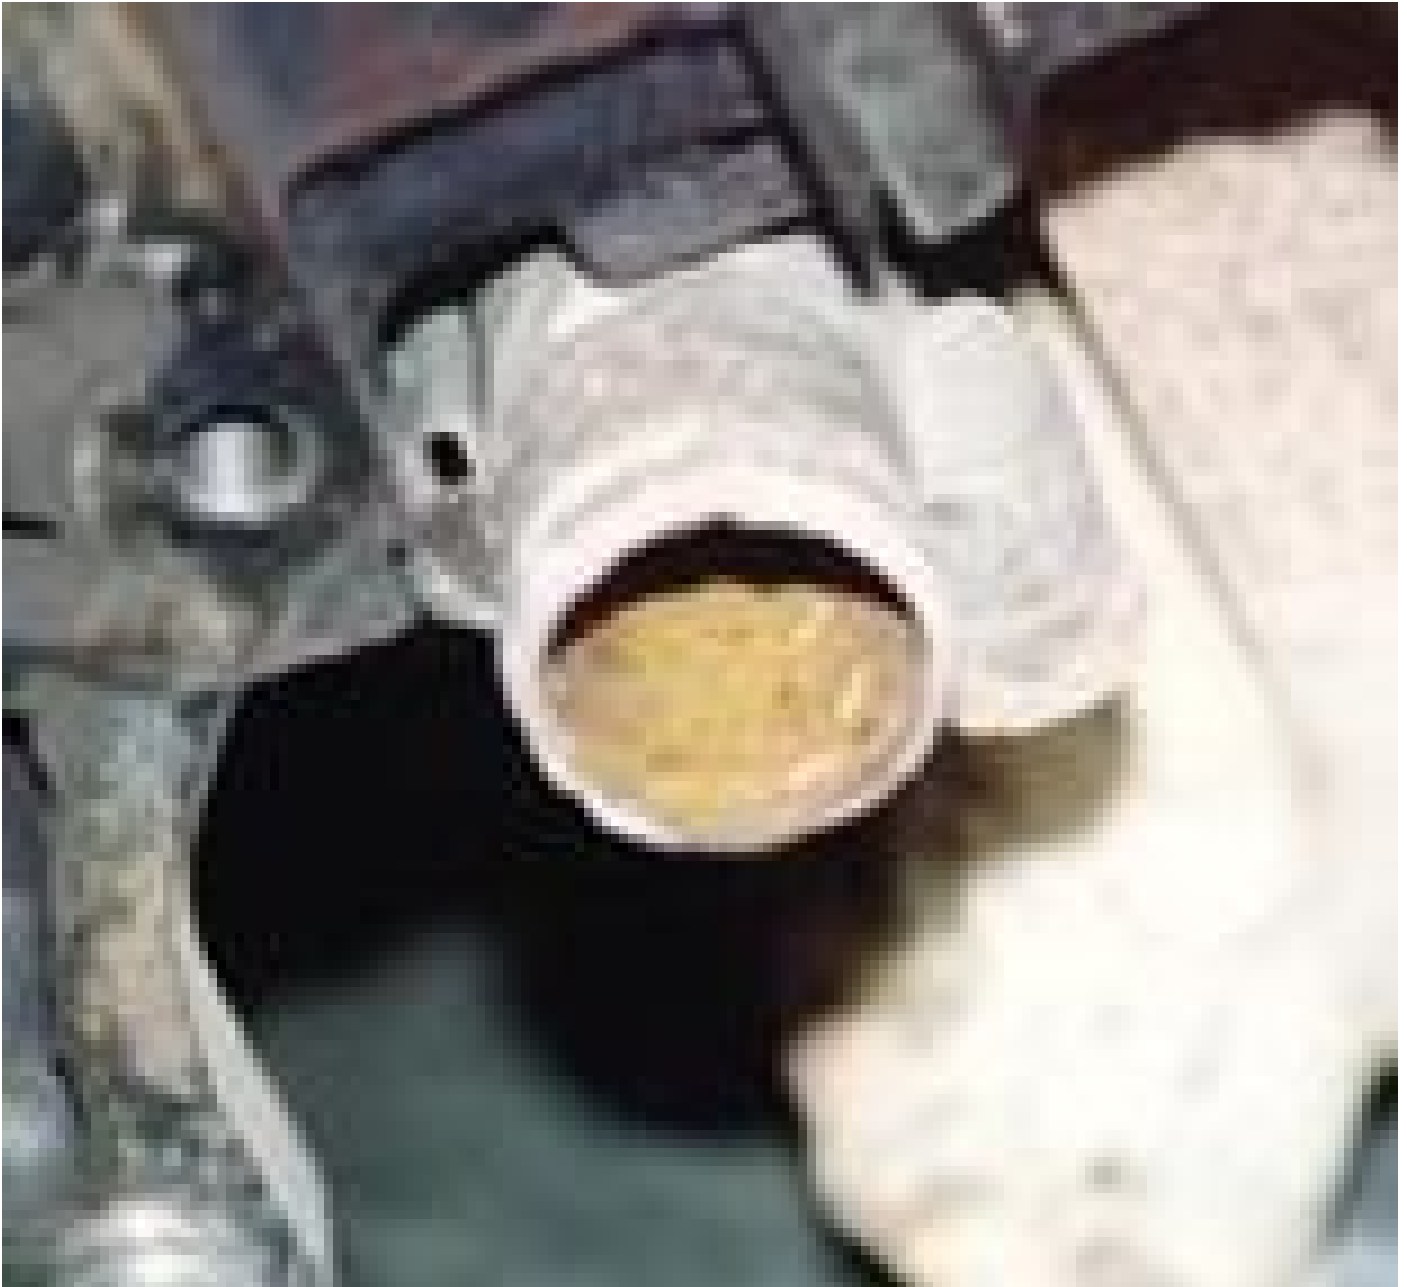
Bild 6

Corrosion in the entire cooling system (Figure 6):

- Defective cylinder head gasket - engine exhaust gases enter the cooling system. Negative variation of pH

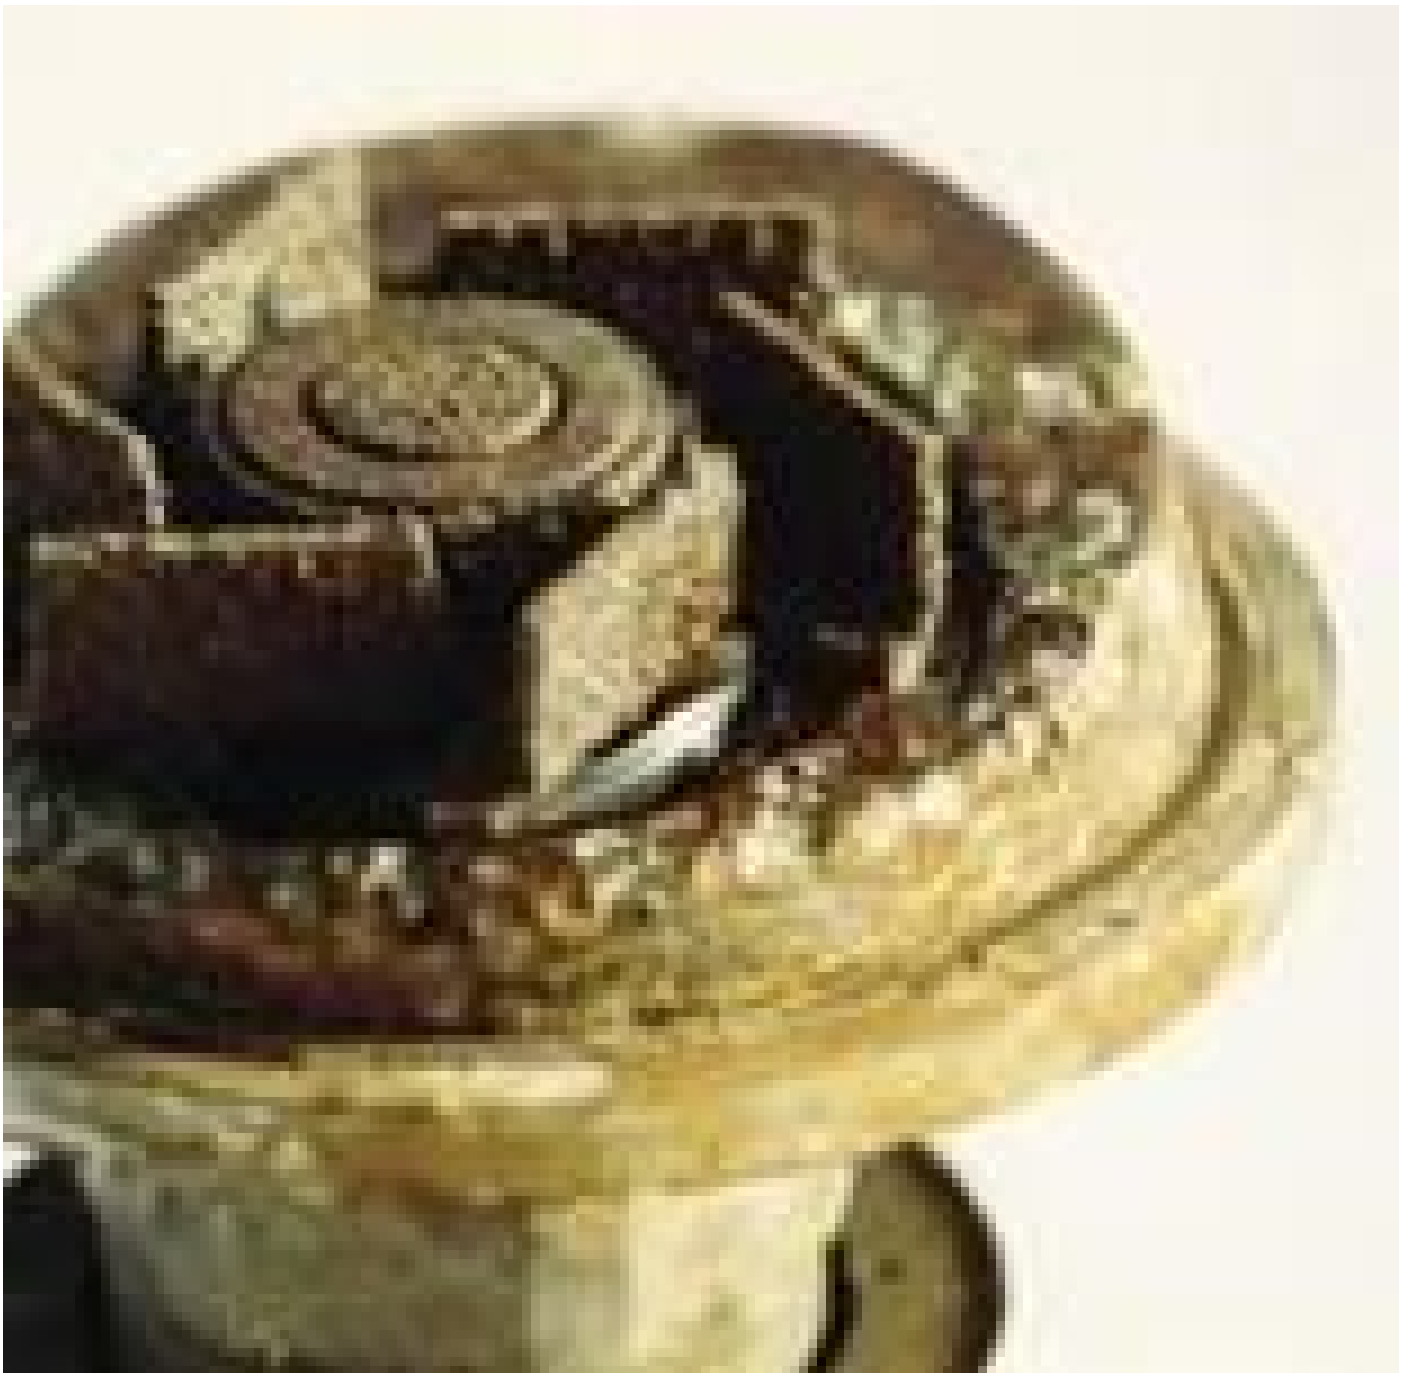
Bild 7

Pump parts such as vane, body, mechanical seal and shaft severely damaged by hole corrosion (Figure 7):-

- Old/stale coolant with high content of chlorides (salt compounds) in conjunction with elevated temperatures.

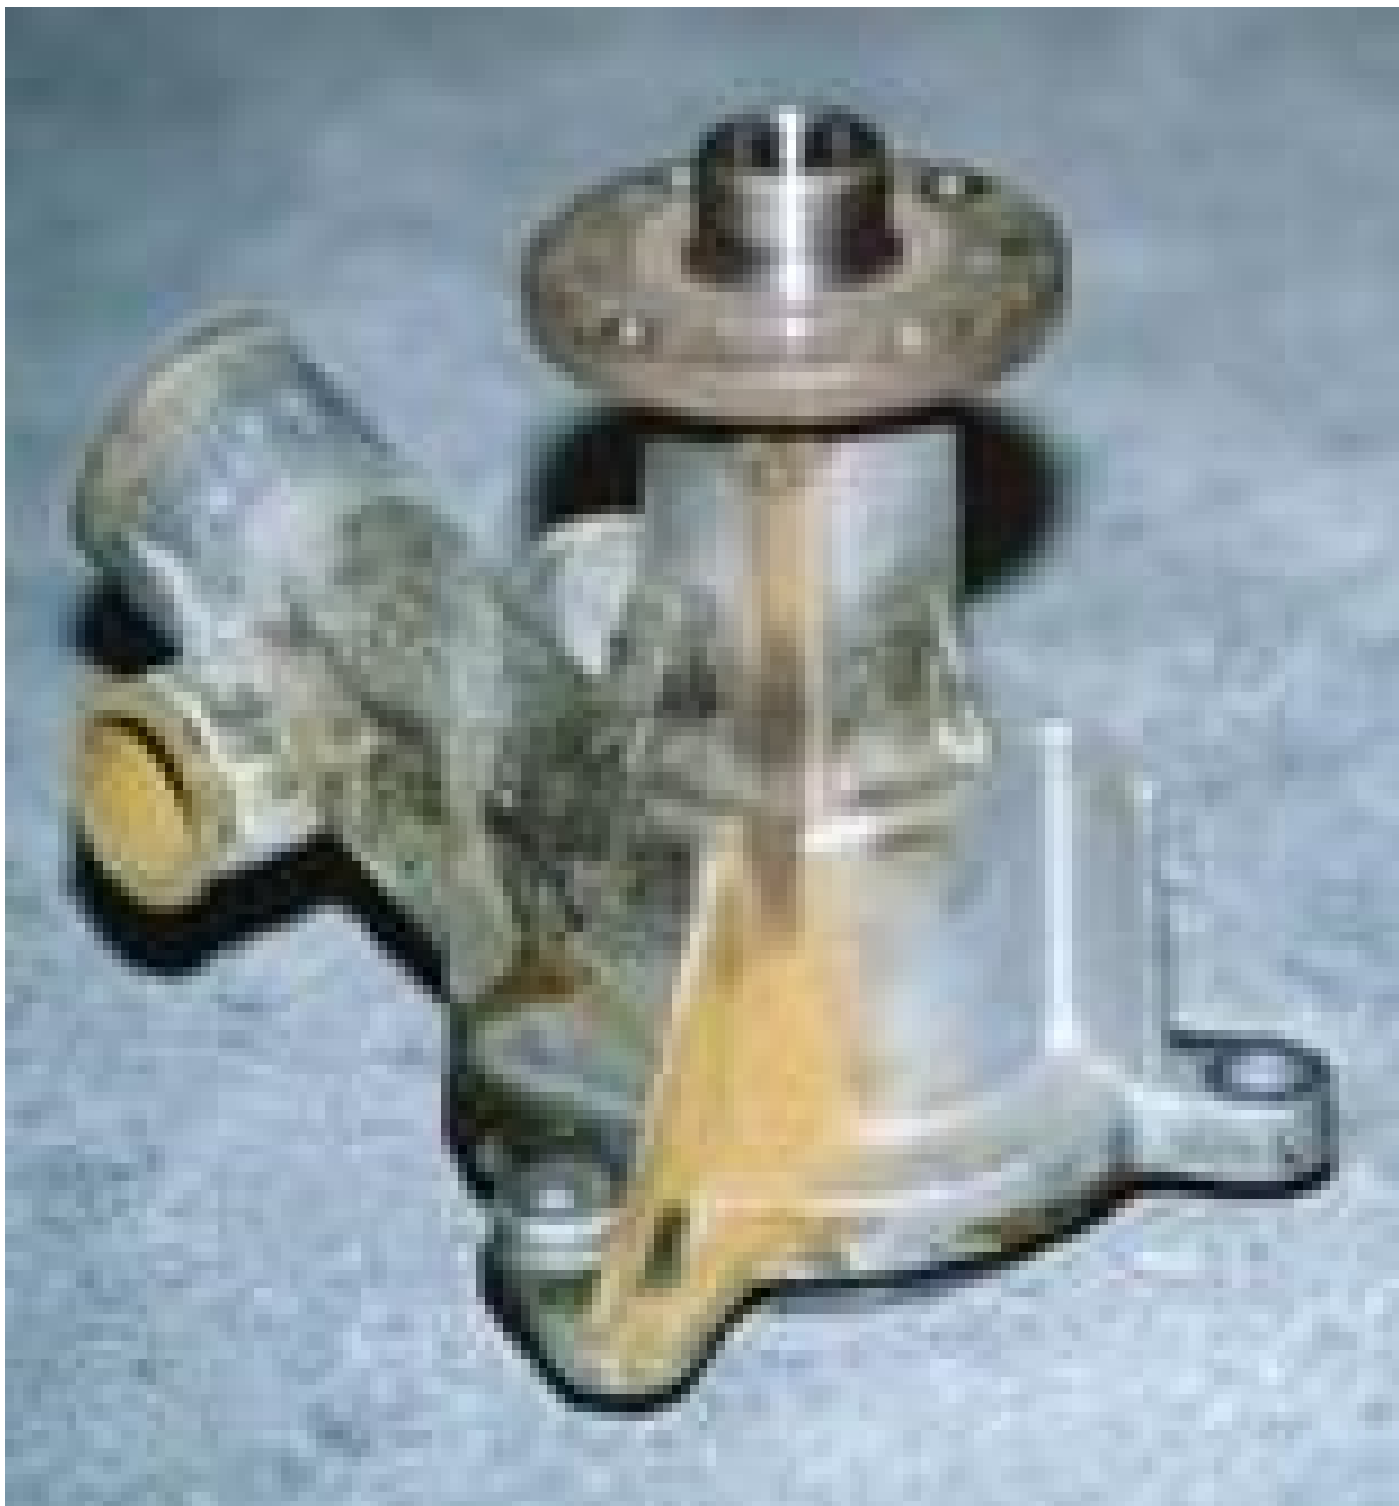
Figure 8

Excessive leakage of coolant from the relief hole (Figure 8):

- Caused by corrosion in the cooling system
