# Fiat Ducato series 3 - Central locking system malfunction | HELLA

**Ducato series 3**

**Type 250**

**Model year: 2006 – 2011**

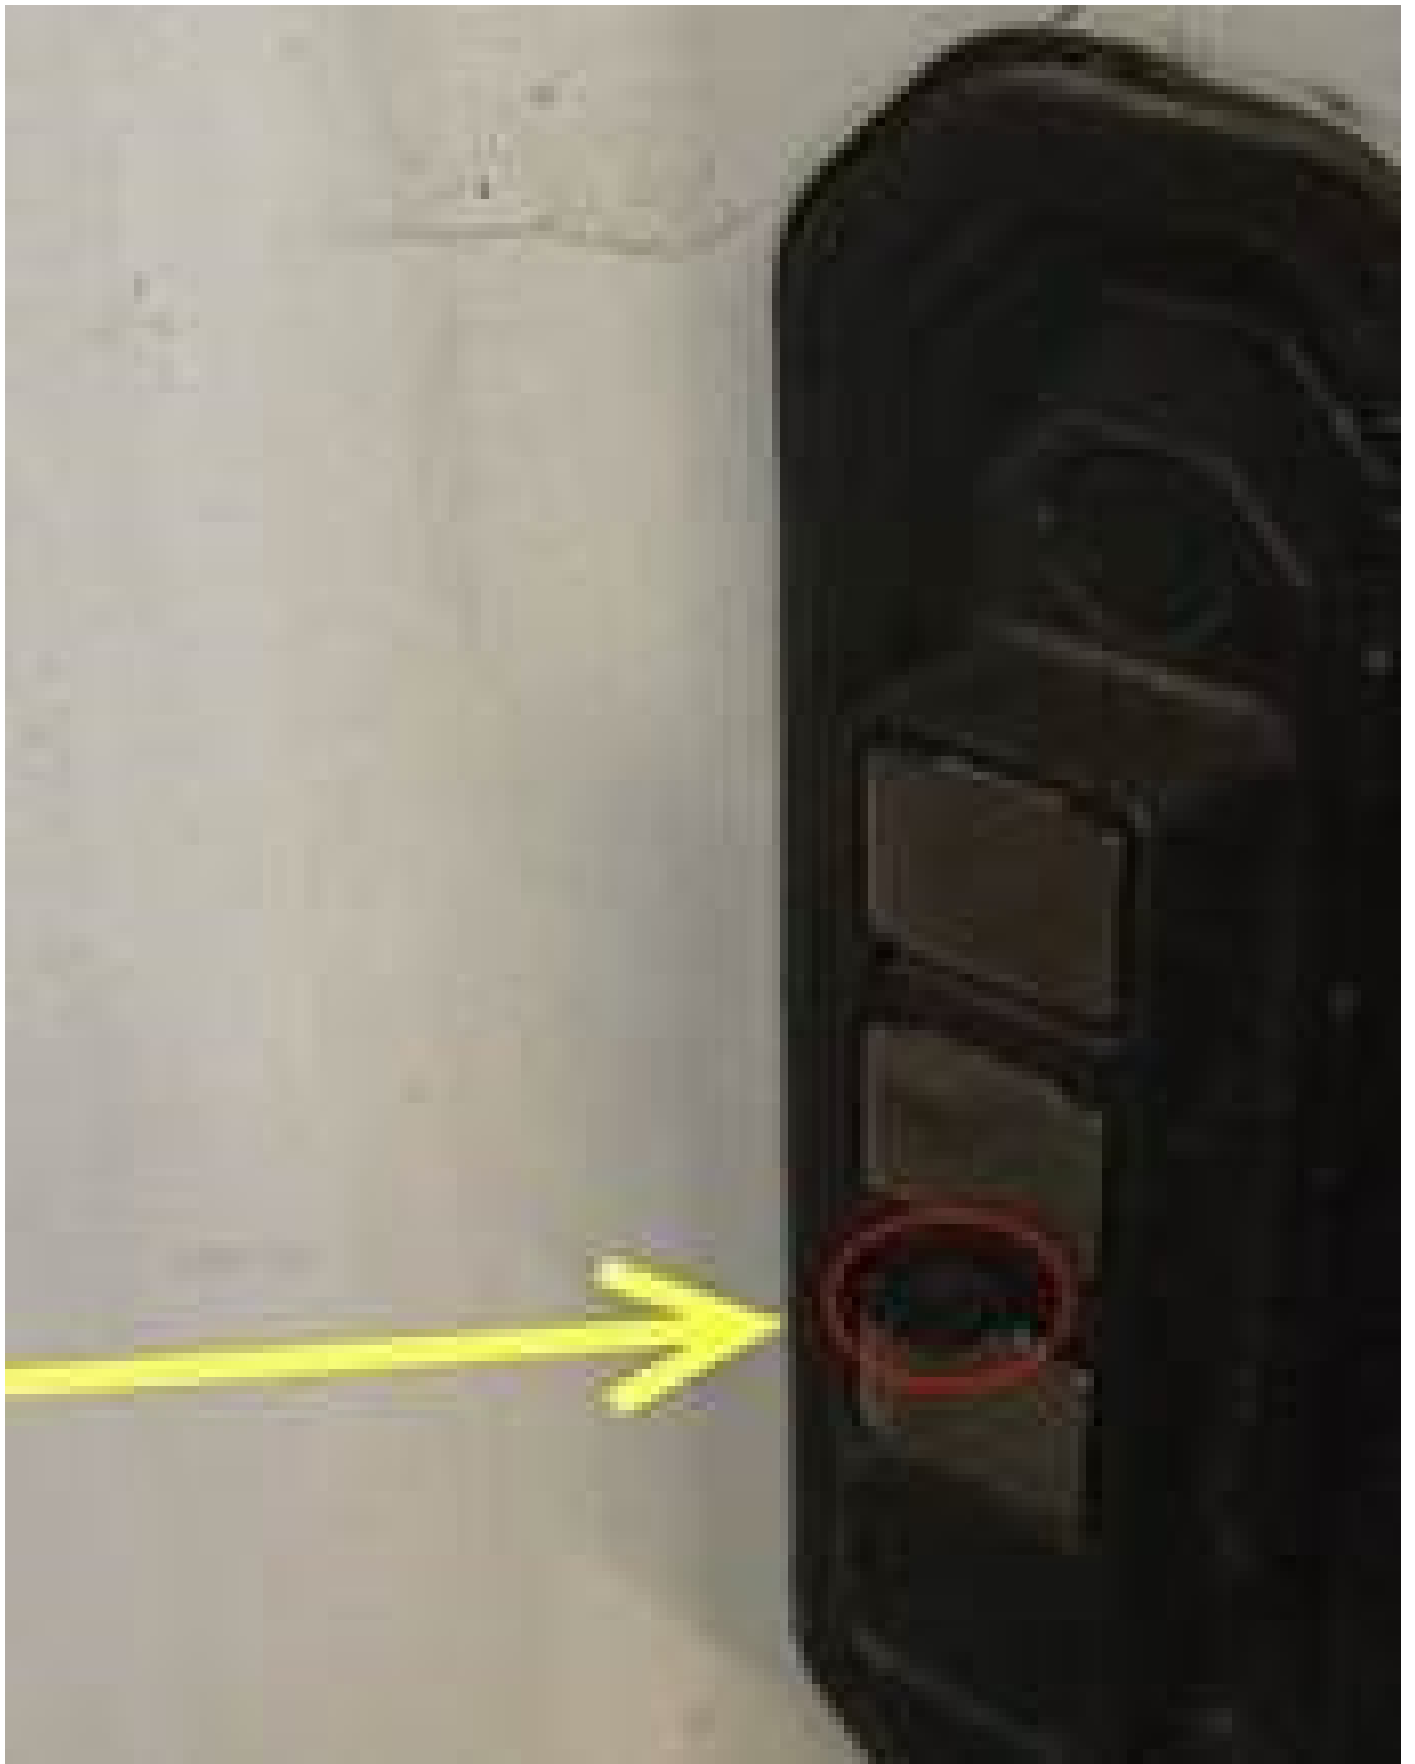
Complaints regarding a malfunction of the central locking system in these vehicles may be associated with an incorrectly positioned or jammed positioning pin in the sliding door's contact plate in the C-pillar.

(See figure).

1. Remove the sliding door contact plate.
2. Check the contact pin of the sliding door's locking detection and provide access to it. The positioning pin must be freely movable after multiple actuations and completely protrude from the plate.
3. Reinstall the sliding door contact plate.
4. Finally check the sliding door's counter contact for electrical continuity and mechanical function. Clean contact surfaces if necessary.
5. Close sliding door and check the central locking system's correct function.
