## Kia Venga - interior blower only runs at the maximum level

Data sheet	
Manufacturer	Kia
Vehicle model	Venga
Engine	All models
Year of manufacture	2016 - 10/2019
Symptoms	Interior blower only runs at the highest level

## Interior blower cannot be turned down

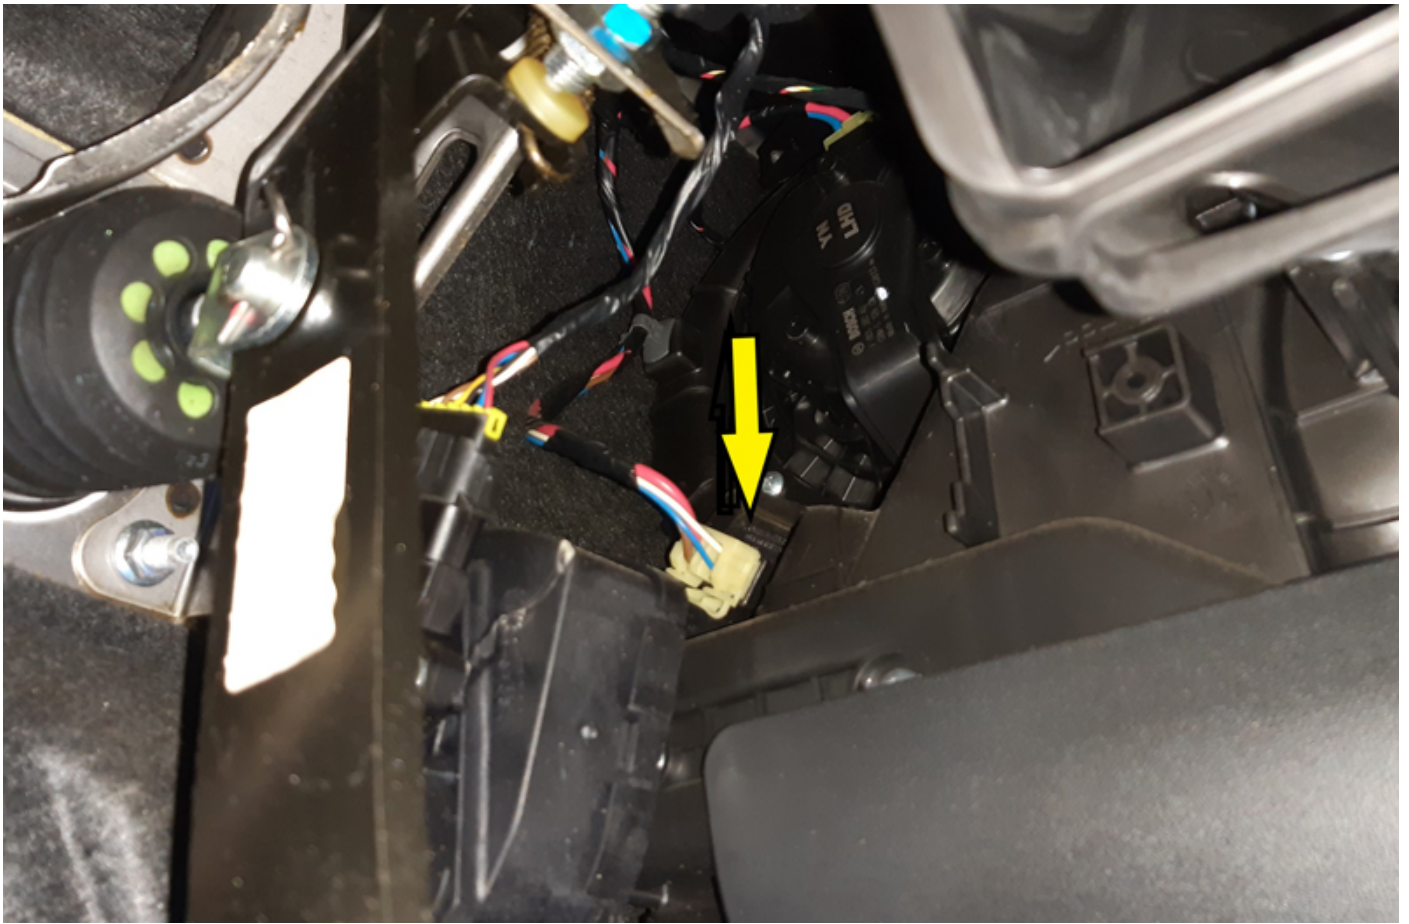
In the vehicles mentioned above with manual air conditioning, the interior blower may only operate at the highest level (maximum fan speed). This is usually an indication that the blower regulator (resistor) is defective. This is also the case with these vehicles. However, it is accessed via the driver's footwell and not via the passenger footwell as is usually the case ([Fig. 1](#)).
