Opel Astra-J Sports Tourer: display code 16

Data sheet

Display code 16

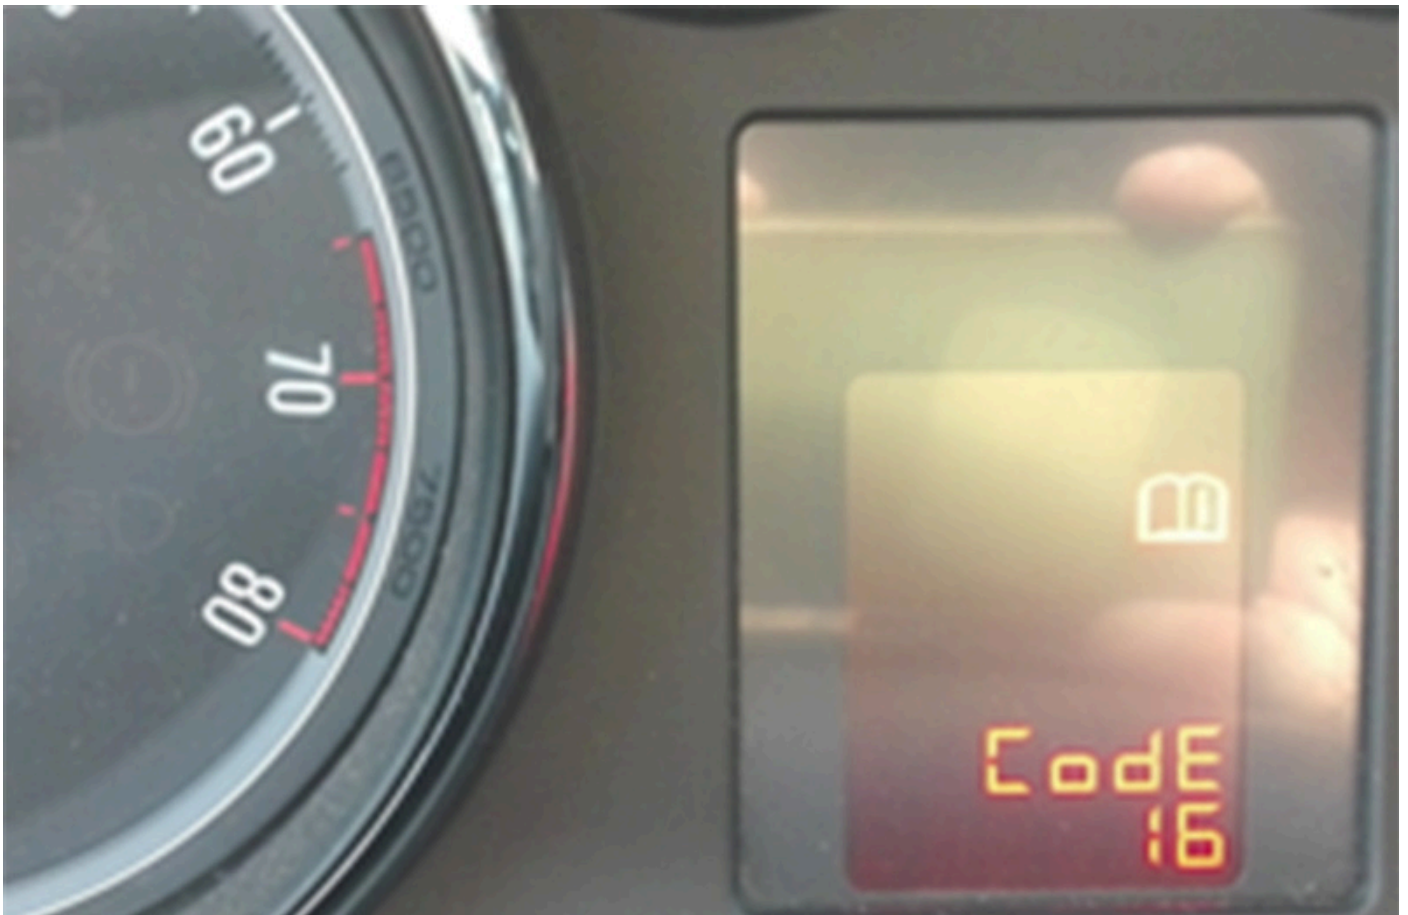
Fig. 1: Code 16 appears on the display

Code 16 appears on the display ([Fig.1](#)) with information, see operating instructions. Error code Diagnosegerät_B3881 corresponds to faulty tail light lamp or circuit.

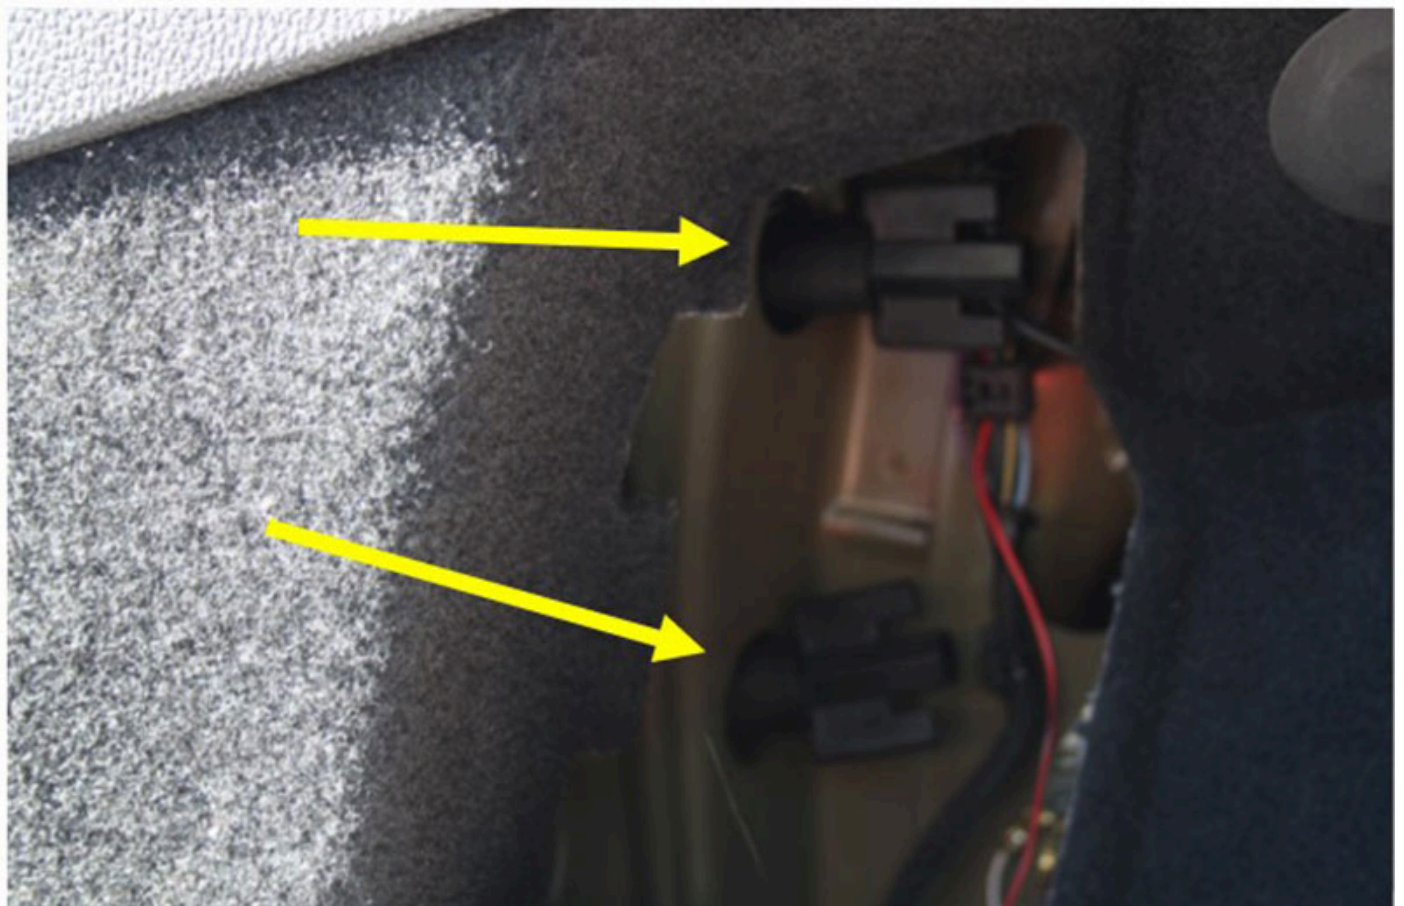
Fig. 2: Internal trim

Check light functions and, in this case, replace the stop light bulb. To do this, open the rear interior trim and loosen the two wing nuts ([Fig.2](#)). Then remove the rear lamp from the vehicle body towards the rear.

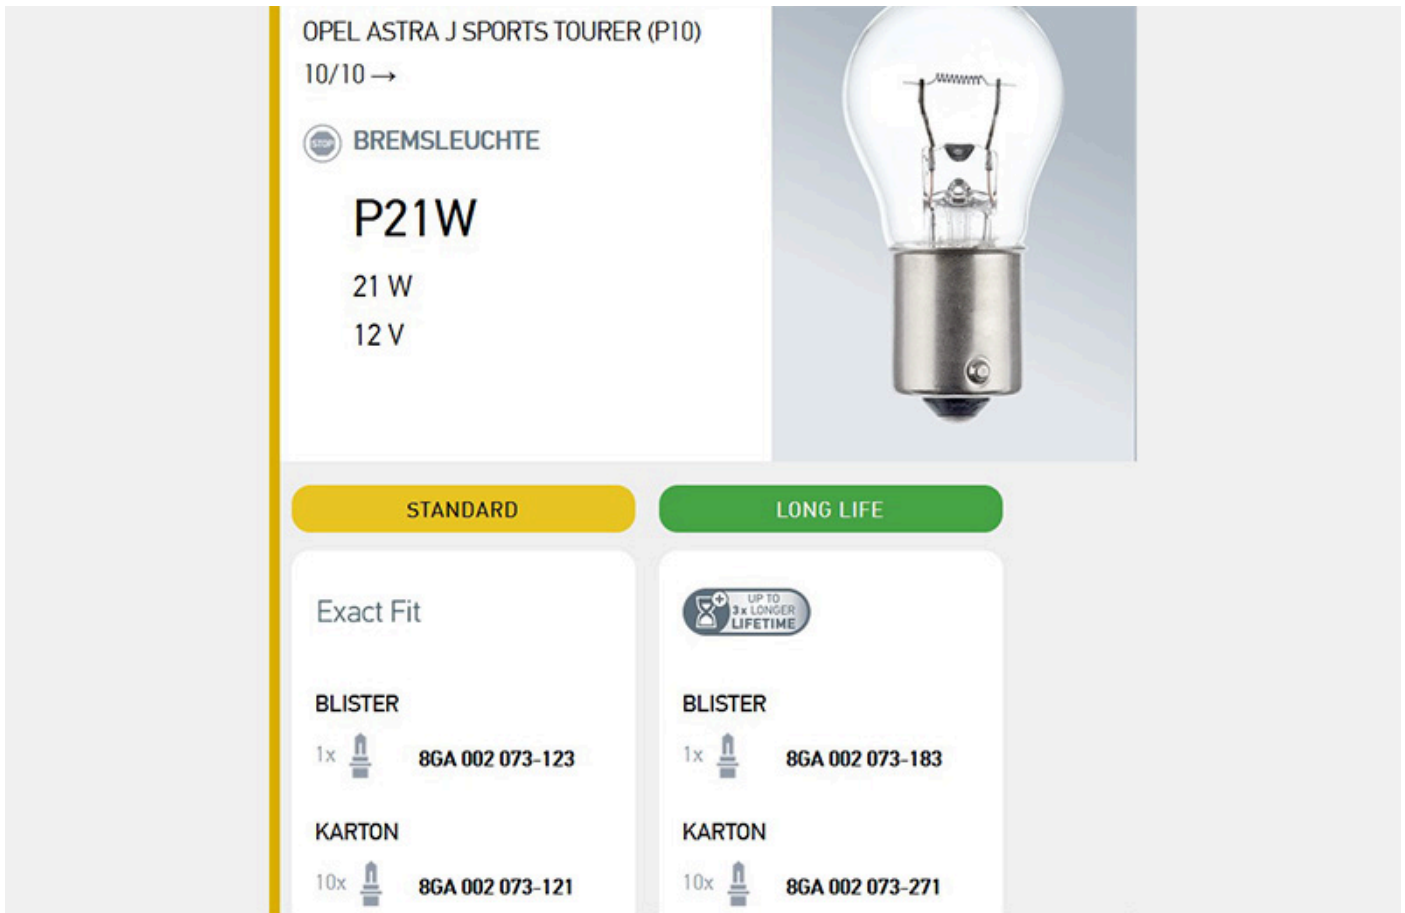
Fig. 3: P21W bulb

Replace P21W bulb ([Fig.3](#)). Check plug contacts for corrosion.

If necessary, delete the error message stored in the control unit via the diagnostic device. Reassemble in reverse order.
